Estates of Glenway

Tree Inventory Report

Project:
Marianneville Developments Ltd.
 Newmarket, Ontario, Canada

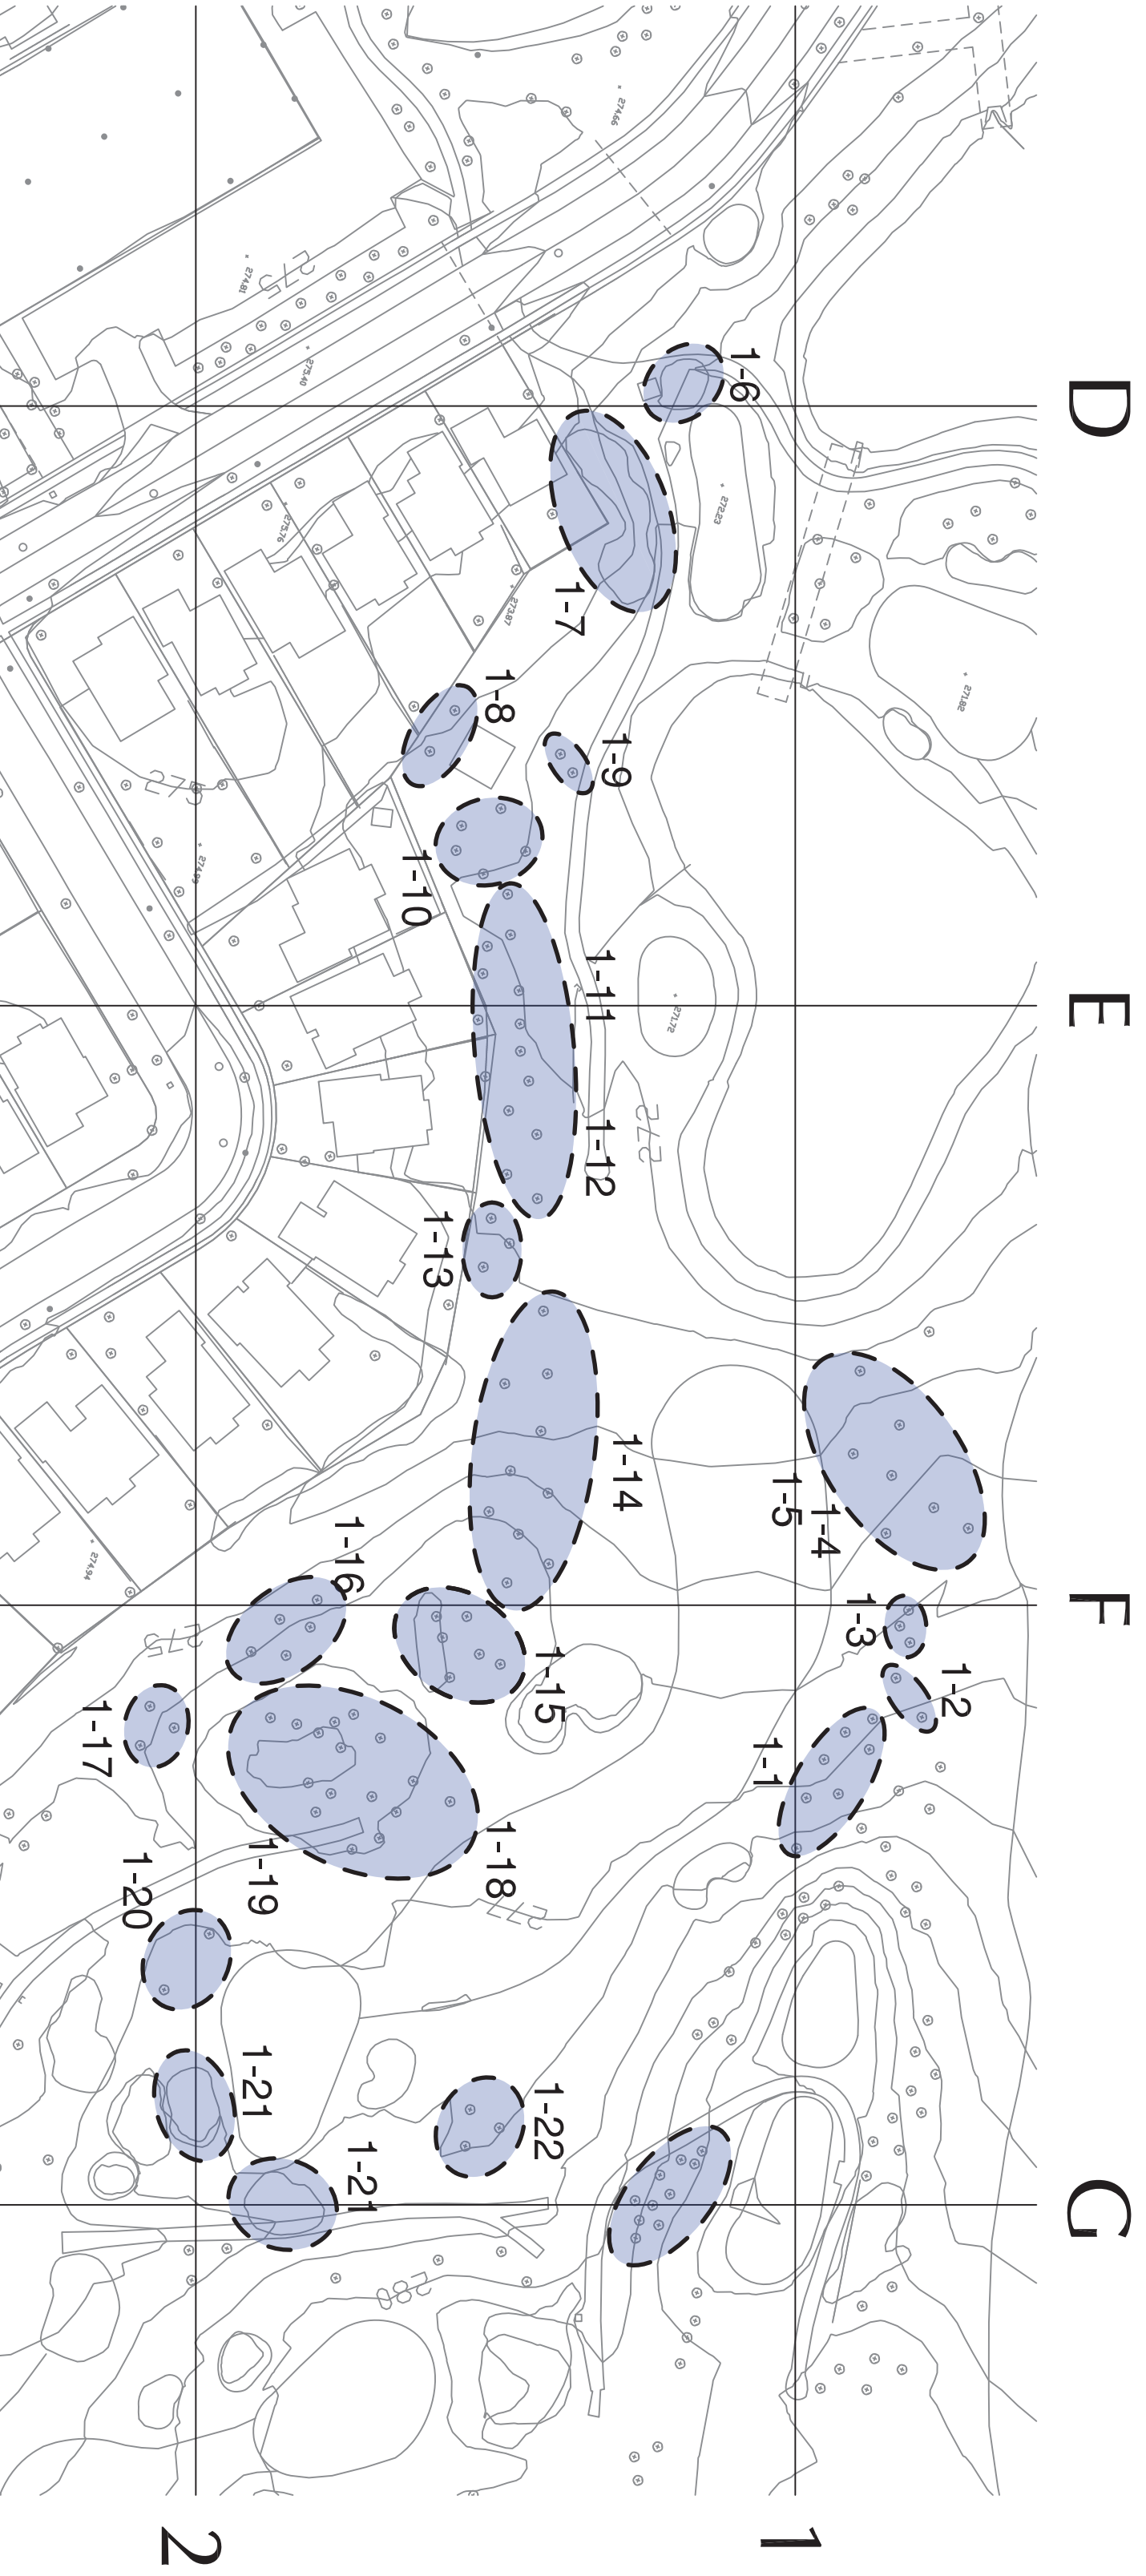
Hole 1 Plan
 scale: 1:1000

Tree No.	Species Botanical Name	Common Name	Qty	Size DBH (cm)	radius (m)	Condition
1	fraxinus americana	White Ash	7	12.0	22.0	fair; lichen fungus
2	betula papyrifera	Paper Birch	2	10-15	3.0	fair; stunted growth; pruned to 3m
3	fraxinus americana	White Ash	3	12-20	3.0	fair; lichen fungus
4	acer platanoides Crimson King	Crimson King Maple	1	20.0	3.0	fair; TS; frost crack; fungus
	picea pungens	Colorado Spruce	2	25.0	3.0	fair; 20% dieback
5	fraxinus americana	White Ash	3	10-15	3.0	2 good; 1 poor - 60% dieback
	salix babylonica	Weeping Willow	1	30.0	3.0	good
6	pinus nigra	Austrian Pine	5	22-30	4.0	good; one leaning
7	pinus nigra	Austrian Pine	5	22-30	4.0	fair; 20% dieback
	picea pungens	Colorado Spruce	5	25-35	4.5	good
8	pinus nigra	Austrian Pine	2	25-35	3.5	fair; 30% dieback; one leaning
9	picea pungens	Colorado Spruce	2	22-30	3.0	good; one leaning; one is topped
10	pinus nigra	Austrian Pine	3	22-30	4.0	poor

picea pungens	Colorado Spruce	2	20-30	4.0	good; dense group; internal branch dieback
11	pinus nigra	Austrian Pine	2	25.0	2.5	fair; one leaning; DTB
	abies balsamea	Balsam Fir	3	15-30	2-4	poor; 30% dieback; one leaning
12	pinus nigra	Austrian Pine	2	25-33	4.5	2 good; 1 poor; 1 dead
	abies balsamea	Balsam Fir	6	25-30	2-4	good; dieback on lower branches
13	acer saccharinum	Silver Maple	5	10-20	2-4	good; 2 succoring
14	fraxinus americana	White Ash	9	12-25	3-4	good; insect tear damage; surface roots; fungus
	acer saccharum	Sugar Maple	1	20.0	3.0	good; minor trunk damage
15	picea pungens	Colorado Spruce	3	25-33	3.0	good; one leaning;
	pinus nigra	Austrian Pine	3	25-33	4.5	2 fair; 1 poor - 30% dieback, no leader
16	acer saccharinum	Silver Maple	5	10-20	2-4	good; grouped
17	fraxinus americana	White Ash	7	10-20	2-4	good; fungus
18	acer saccharinum	Silver Maple	6	12-25	2-4	good; one succoring; one with minor trunk damage; roots exposed

acer platanoides	Norway Maple	5	20-25	3-3.5	good; surface roots; trunk damage on one
19	picea pungens	Colorado Spruce	5	20-35	3-3.5	good; dense group
20	acer platanoides	Norway Maple	1	30.0	5.0	good; flare trunk; surface roots; TS
	acer saccharum	Sugar Maple	1	20.0	2.5	good
21	pinus nigra	Austrian Pine	5	35-45	4.5	good; minor trunk damage and DTB
22	acer saccharinum	Silver Maple	3	15-20	4.5-6	good; succoring

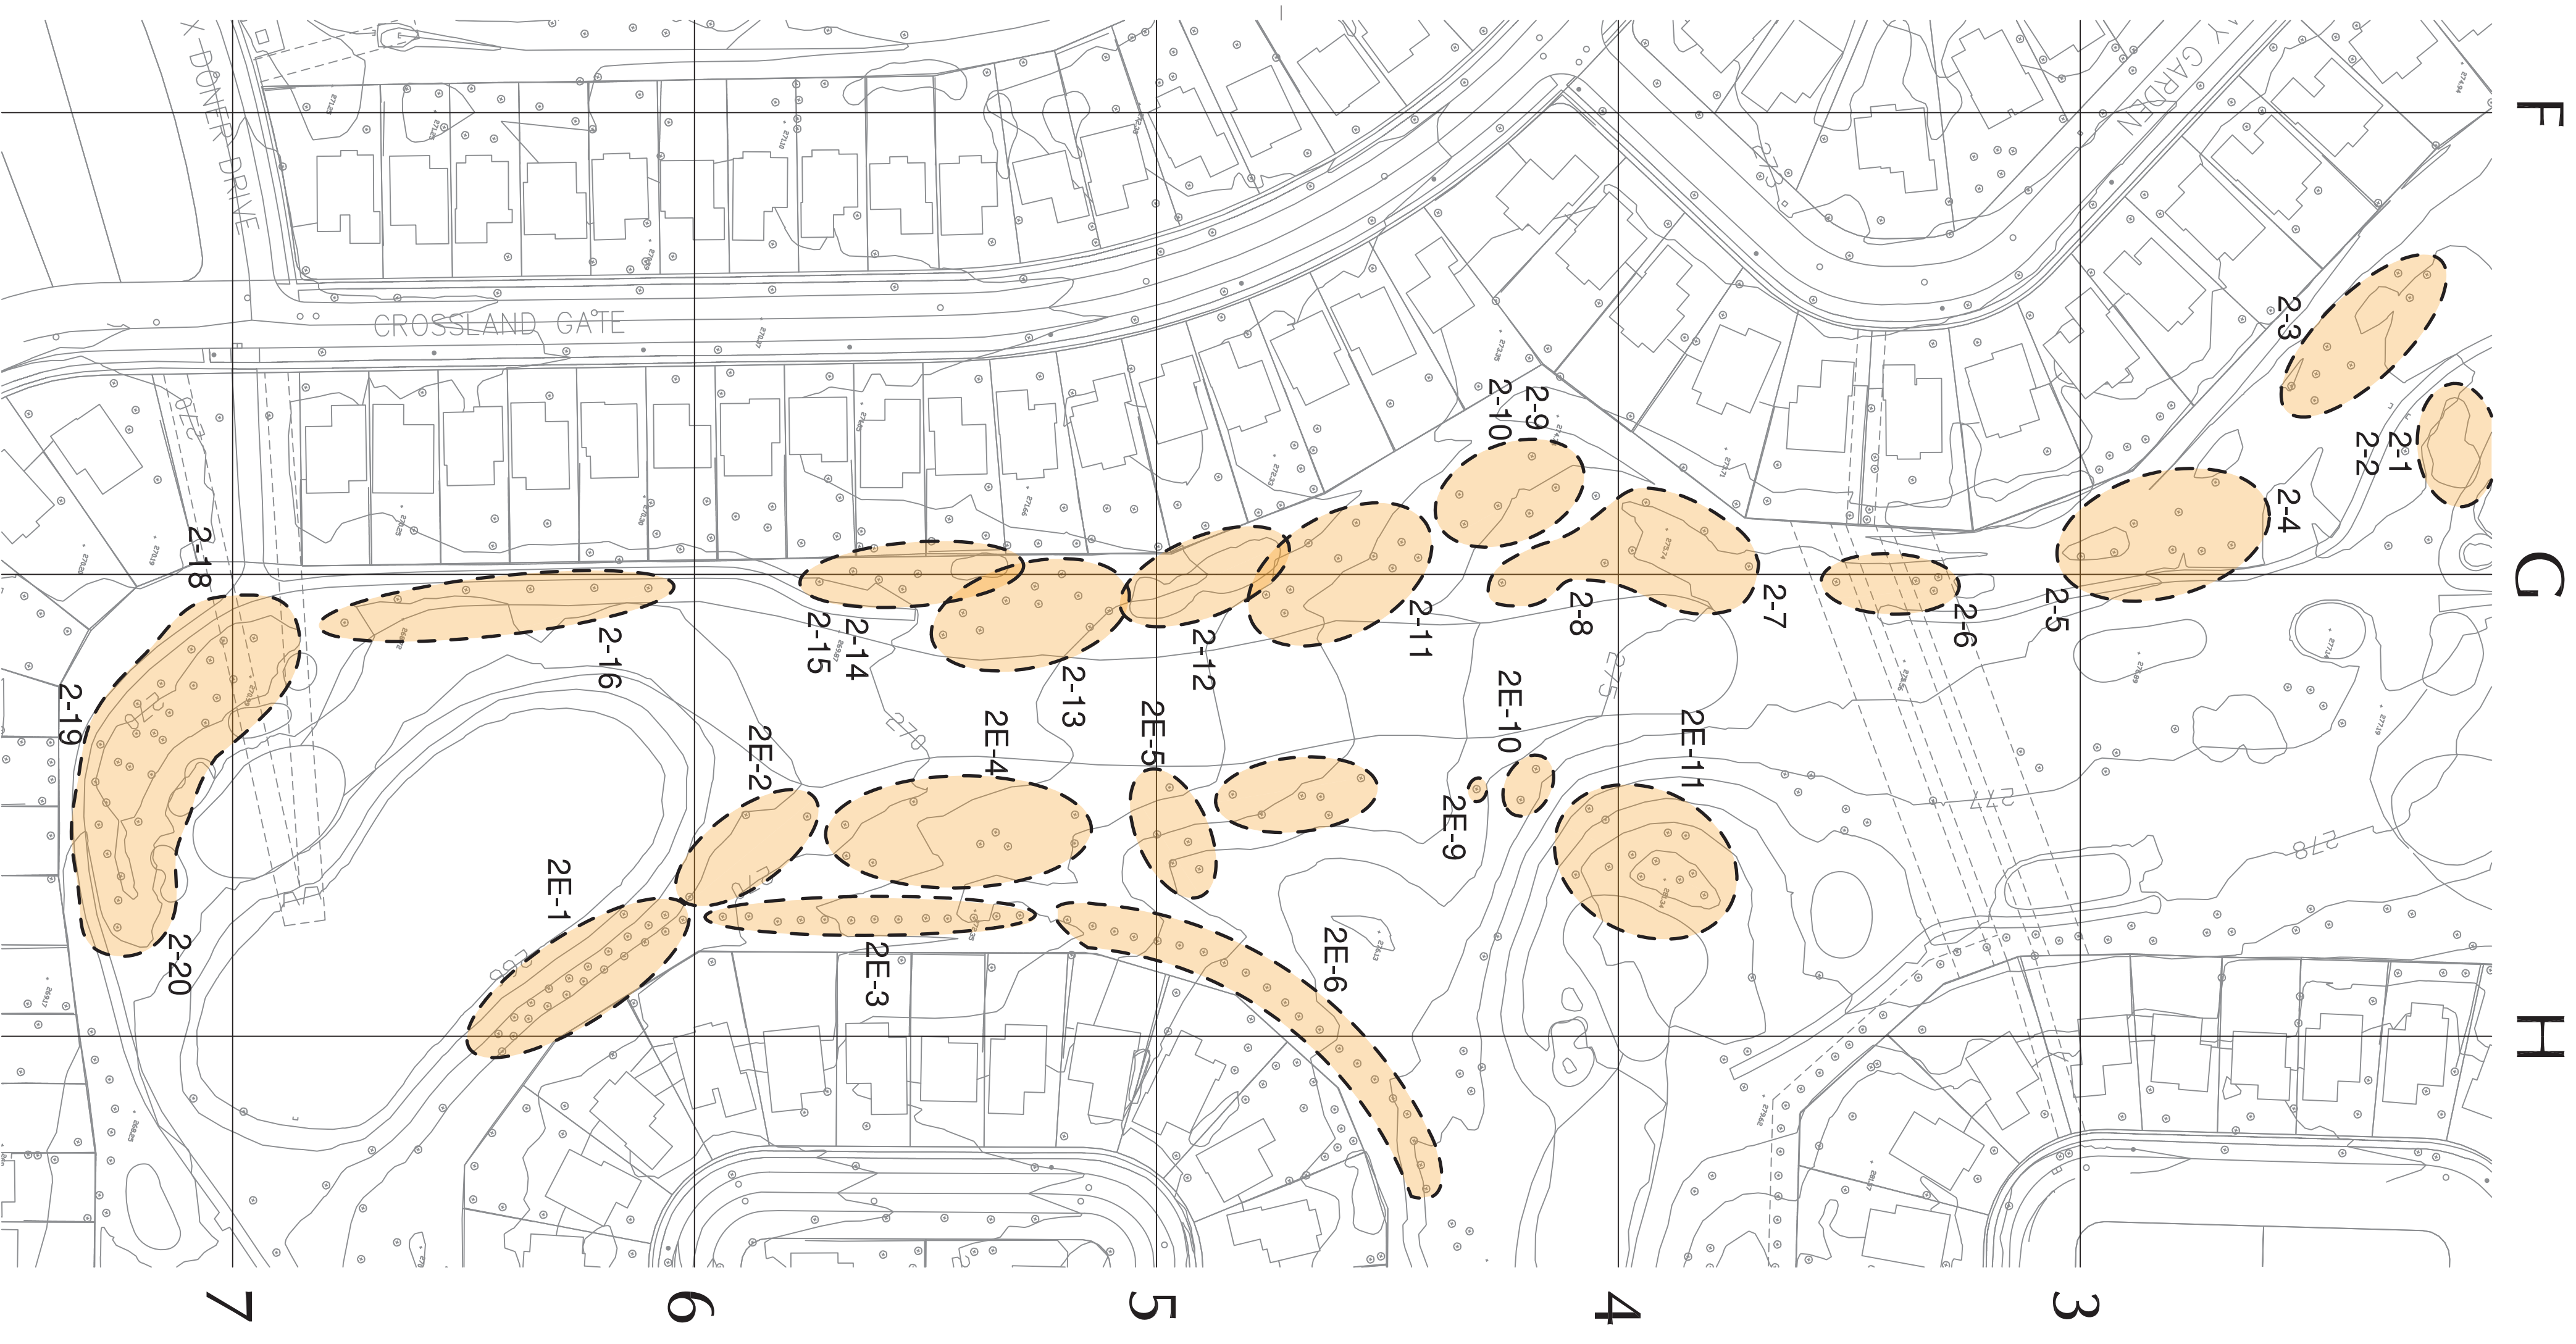
Hole 2 Plan
 scale: 1:1000

Tree No.	Species Botanical Name	Common Name	Qty	Size DBH (cm)	radius (m)	Condition
1	abies balsamea	Balsam Fir	4	2-4m ht	2.0	good; located on slope
2	betula pendula	European Birch	3	35.0	3.5	2 good; 1 poor 40% dieback
3	abies balsamea	Balsam Fir	13	5.0	3-4.5m ht	good
4	acer saccharinum	Silver Maple	9	15-35	4.0	good; pruned high; surface roots
5	acer saccharinum	Silver Maple	1	45.0	5.0	good
	fraxinus americana	White Ash	4	10-15	2-3	good; surface roots
6	abies balsamea	Balsam Fir	21	5-8	3-7mht	19 good; 2 fair
7	acer platanoides	Norway Maple	2	12.0	2.0	1 good; 1 poor
	acer saccharinum	Silver Maple	3	12-18	2-3.5	good
8	acer saccharinum	Silver Maple	1	dbl stem	2.5	fair; lichen fungus
9	fraxinus americana	White Ash	1	95.0	8.5	good; some dieback and insect damage on leaves
10	acer platanoides	Norway Maple	2	18.0	3.0	good; surface roots
11	pinus nigra	Austrian Pine	7	18.0	3.0	1 good; 6 poor; DTB
	picea pungens	Colorado Spruce	5	35.0	4.5	4 good; 1 poor; dieback and leaning

Tree No.	Species Botanical Name	Common Name	Qty	Size DBH (cm)	radius (m)	Condition
1	malus sp.	Apple	3	2-4m ht	2.0	original farm hedgerow; trees overmature
	crateagus sp	Dotted Hawthorn	5	multistem		original farm hedgerow; trees overmature
2	prunus sp	Cherry	1	7.0		covered in vines - poor
3	acer saccharinum	Silver Maple	8	18-30	4.0	fair; succoring
4	abies balsamea	Balsam Fir	1	30.0	4.5	good
	populus tremuloides	Trembling Aspen	1	30.0	4.5	poor 30% dieback
5	fraxinus americana	White Ash	1	18.0	2.5	good
	acer saccharinum	Silver Maple	3	25-30	3-4	good; one succoring; one with frost crack
6	pinus nigra	Austrian Pine	2	30.0	3.0	poor 30% dieback
7	picea pungens	Colorado Spruce	1	35.0	3.5	good
	abies balsamea	Balsam Fir	5	30-35	3.0	good
8	pinus nigra	Austrian Pine	2	30-35	3.0	good; some DTB
	fraxinus americana	White Ash	1	15.0	3.0	good
9	acer saccharinum	Silver Maple	5	18-25	3.0	good; 2 succoring
	acer saccharum	Sugar Maple	1	multistem	4.5	good; unusual; trunk fungus

10	ostrya virginiana	Hophornbeam	1	5.0	3.0	good; growing together
	fraxinus americana	White Ash	1	15.0	3.0	
11	acer platanoides	Norway Maple	6	22-33	6.0	good; surface roots; TS
	abies balsamea	Balsam Fir	3	35.0	3.5	good
12	pinus strobus	White Pine	4	33-38	3.5	good
	picea pungens	Colorado Spruce	4	33-38	3.5	good
13	acer saccharinum	Silver Maple	5	20-30	3.5	good; 2 succoring
	pinus strobus	White Pine	3	20-30	3.5	good; one weeping out trunk
	abies balsamea	Balsam Fir	2	30.0	3.5	good
14	pinus nigra	Austrian Pine	2	30.0	3.5	good; 10 % dieback
	abies balsamea	Balsam Fir	4	25.0	3.5	3 good; 1 fair - 20% dieback
15	acer platanoides Crimson King	Crimson King Maple	1	20.0	3.0	good; trunk damage
16	tilia cordata	Littleleaf Linden	4	18-30	2.5-3	good; trunk damage
	abies balsamea	Balsam Fir	3	30.0	3.0	good

17	chamaecyparis nootkatensis	Weeping Nootka False Cypress	2	10.0	6m ht	good
18	fraxinus americana	White Ash	5	10-15	2.0	good
	acer saccharinum	Silver Maple	11	10-15	2.0	good, 2 with trunk damage; surface roots; succoring
19	abies balsamea	Balsam Fir	5	20.0	3.0	good
	picea pungens	Colorado Spruce	2	20.0	3.0	good
20	acer platanoides	Norway Maple	2	18.0	3.0	good
21

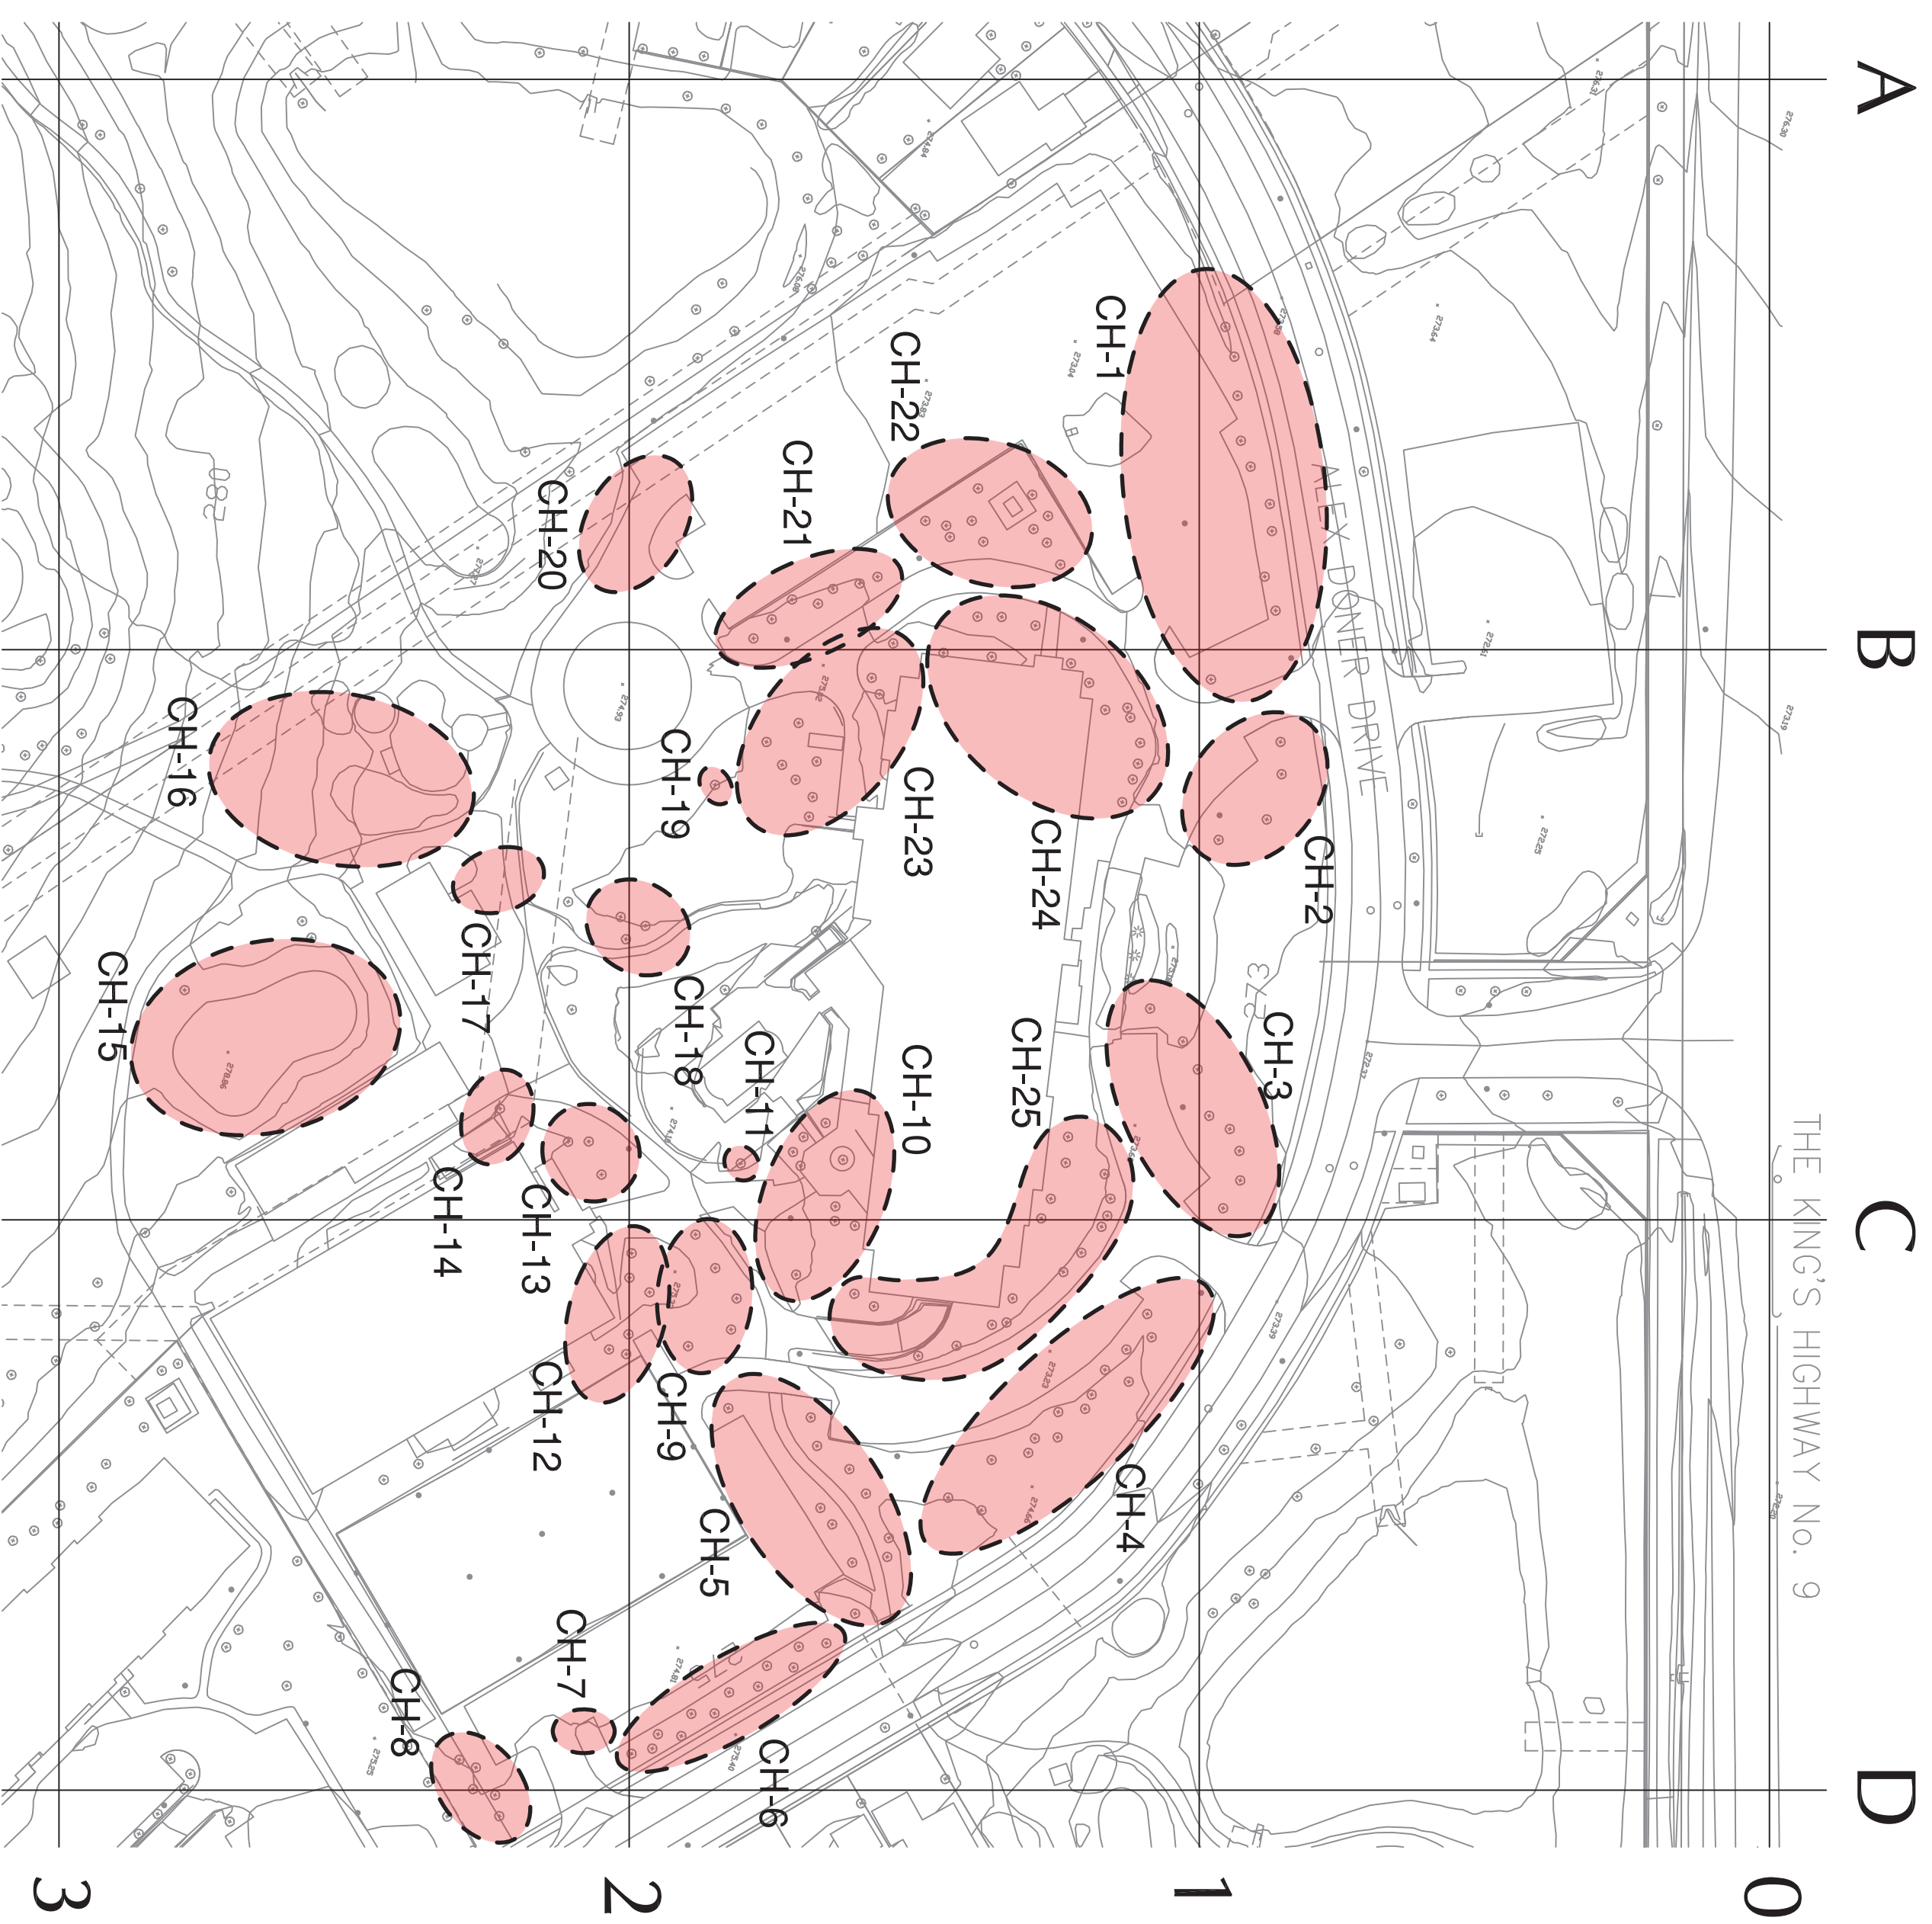
Club House Plan
 scale: 1:1000

Tree No.	Species Botanical Name	Common Name	Qty	Size DBH (cm)	radius (m)	Condition
1	picea pungens	Colorado Spruce	6	15-25	3.0	good
	acer platanoides	Norway Maple	4	15.0	3.0	good; TS
2	quercus rubra	Red Oak	2	5.0	2.0	good
	fraxinus americana	White Ash	1	20.0	3.0	good
	picea pungens	Colorado Spruce	3	1@25, 2@2mht	1@3, 2@1m	good
3	quercus rubra	Red Oak	1	12.0	2.5	good
	quercus palustris	Pin Oak	3	22.0	4.0	good; minor dieback
	picea pungens	Colorado Spruce	2	8.0	6mht	good
	abies balsamea	Balsam Fir	2	8.0	6mht	good
4	picea pungens	Colorado Spruce	10	20.0	3.0	good
	acer saccharinum	Silver Maple	4	20.0	4.5	good;
5	picea pungens	Colorado Spruce	5	20.0	3.0	good
	acer saccharinum	Silver Maple	1	35.0	4.5	good;
	acer platanoides	Norway Maple	5	25.0	3.0	good; TS
6	picea pungens	Colorado Spruce	12	20.0	3.0	good
7	quercus rubra	Red Oak	1	5.0	1.0	good
8	picea pungens	Colorado Spruce	5	25.0	3.5	good
9	acer platanoides	Norway Maple	6	25.0	3.0	good; TS

10	chamaecyparis nootkatensis	Nootka False Cypress	3	8.0	3.0	good
	betula papyrifera	European Birch	1	20.0	3.5	good
11	acer platanoides	Norway Maple	1	25.0	3.0	good health, contorted growth
12	picea pungens	Colorado Spruce	6	20-25	3.5	good;
13	picea pungens	Colorado Spruce	3	20-25	3.5	good;
14	fraxinus americana	White Ash	1	25.0	4.0	good
15	malus sp	Apple	1	18.0	2.0	good health, pruned growth
	fraxinus americana	White Ash	2	15.0	3.0	good
16	malus sp	Crabapple	3	15.0	3.5	good;
17	acer saccharinum	Silver Maple	1	30.0	3.5	good
18	abies balsamea	Balsam Fir	1	30.0	3.0	good
	picea pungens	Colorado Spruce	2	30.0	3.0	good
19	acer platanoides	Norway Maple	1	12.0	2.0	good
20	malus sp	Crabapple	2	15.0	3.5	good;
21	acer platanoides	Norway Maple	2	18.0	3.0	good
	picea pungens	Colorado Spruce	5	20.0	3.0	good

22	fraxinus americana	White Ash	3	10.0	1.5	good
	acer ginnala	Amur Maple	2	multistem	2.5m ht	good
	picea pungens	Colorado Spruce	6	20.0	3.0	good
23	picea pungens	Colorado Spruce	9	20.0	3.0	8 good; 1 dead
24	picea pungens	Colorado Spruce	2	35.0	4.5	good
	malus sp	Crabapple	8	20-25	3.5	good;

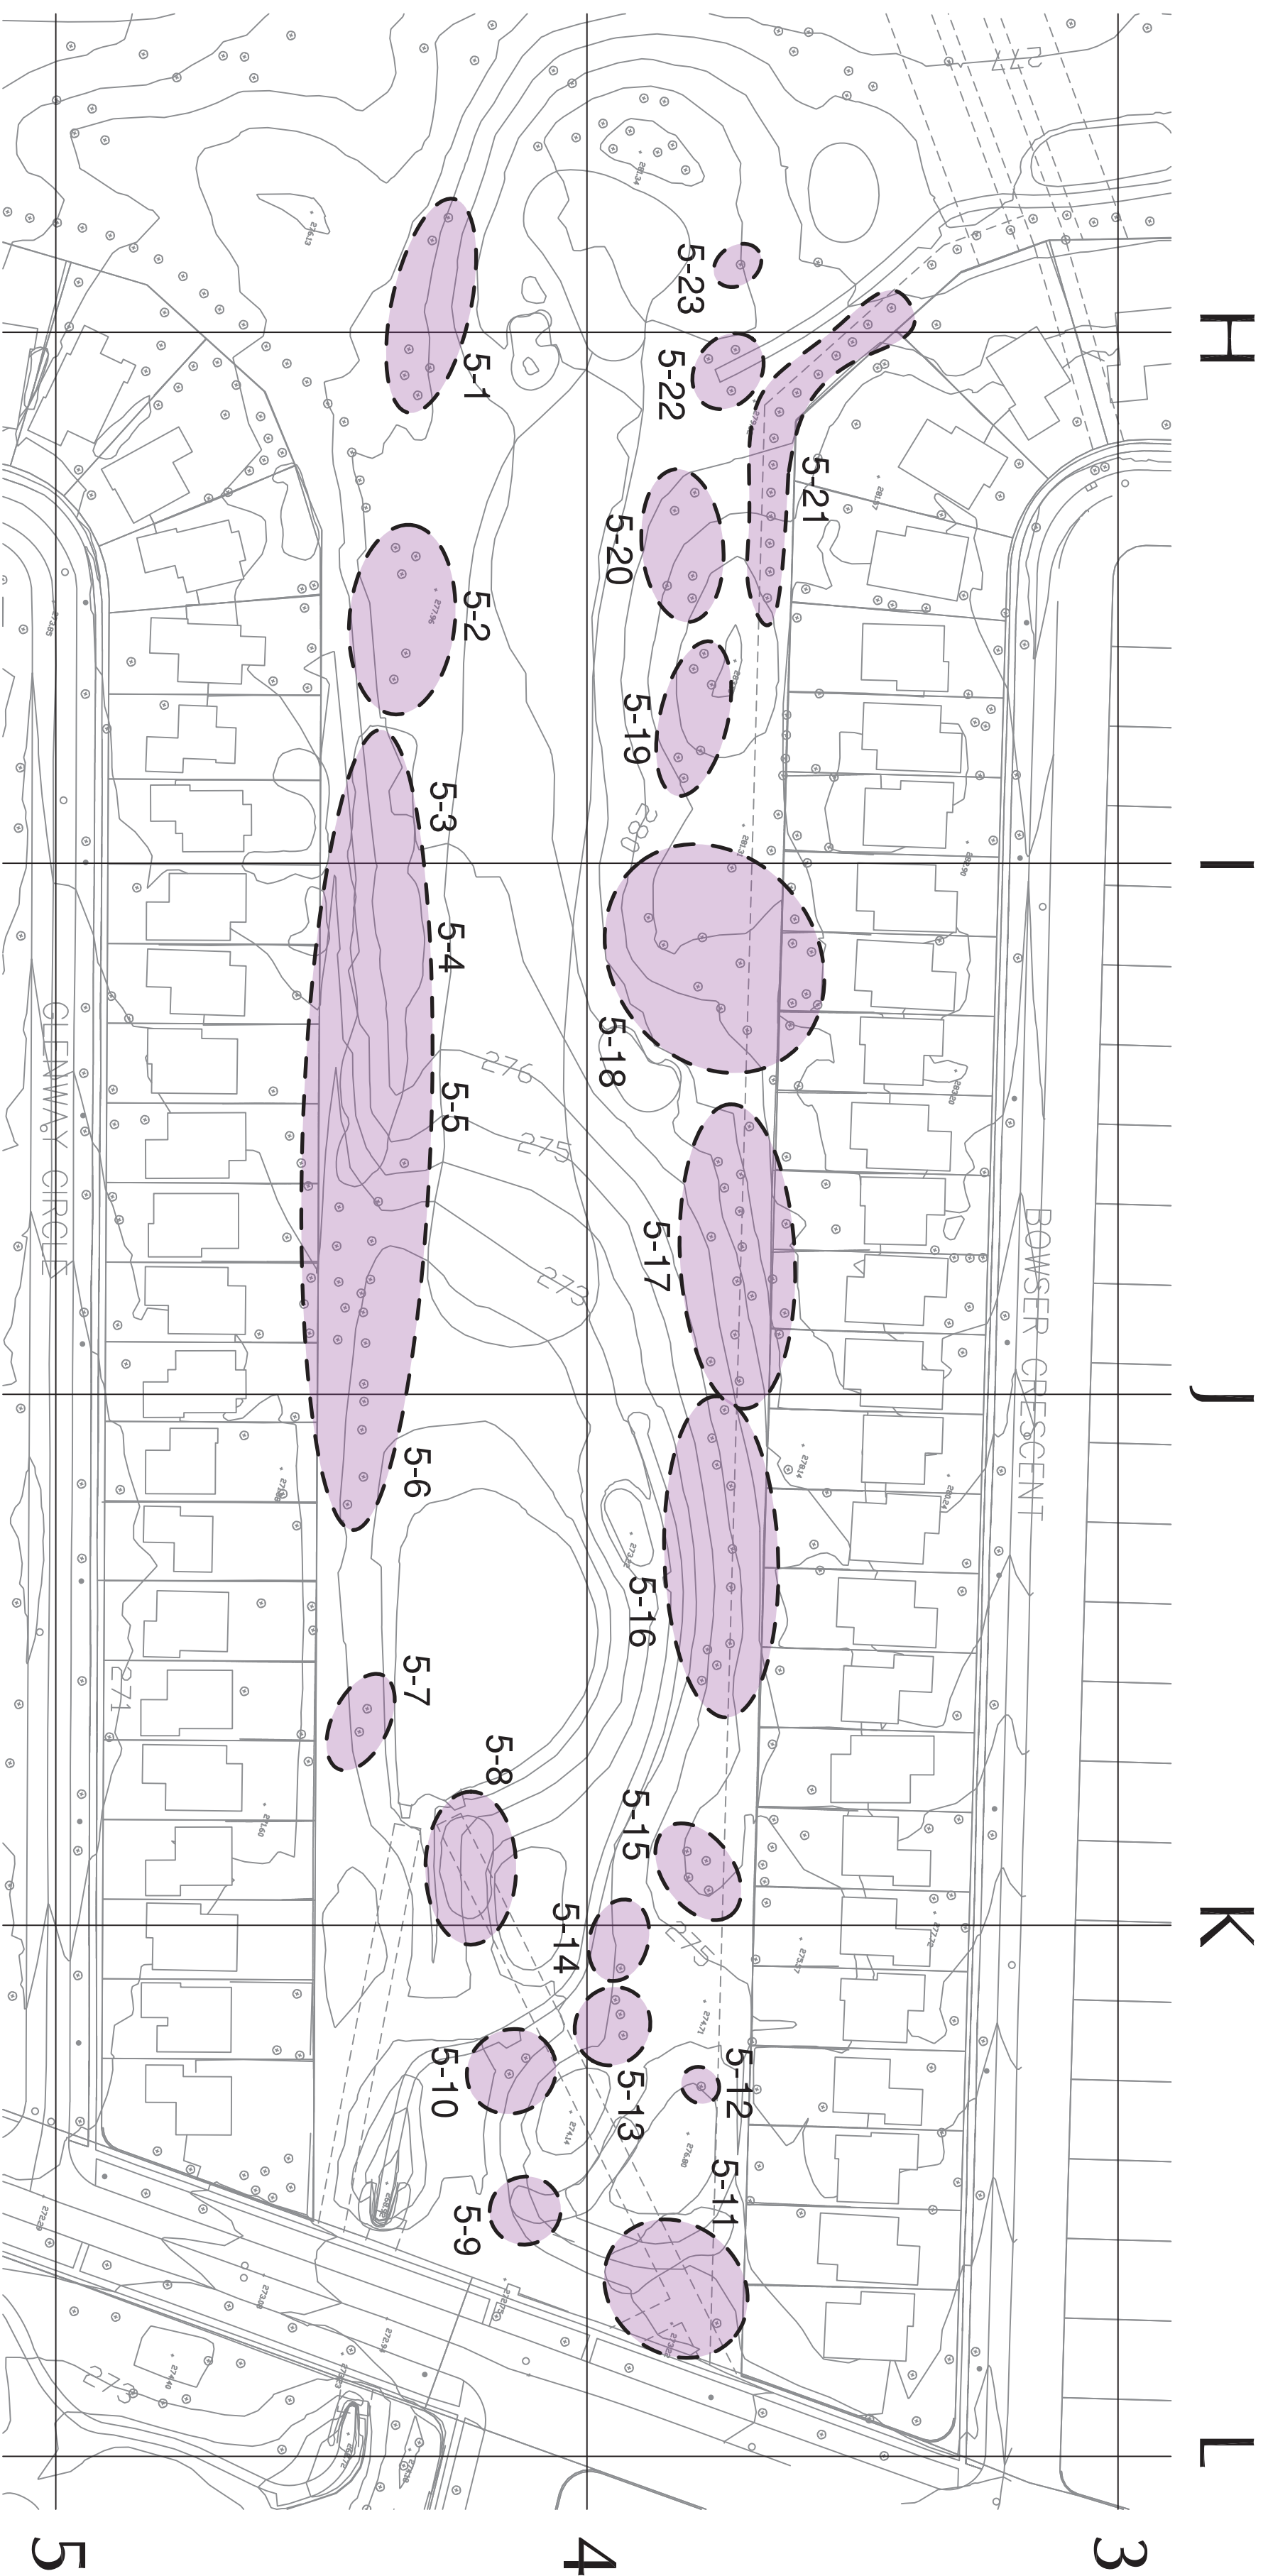
3 Hole 5 Plan Scale 1:1000

Tree No.	Species Botanical Name	Common Name	Qty	Size DBH (cm)	radius (m)	Condition
1	acer saccharinum	Silver Maple	6	12-15	2.5	good; 1 has damaged trunk; surface roots; 4 are succoring
2	acer platanoides	Norway Maple	2	30.0	3.5	good; surface roots; TS
3	pinus strobus	White Pine	18	20-30	3-4.5	16 good; 1 poor; 1 dead
	pinus nigra	Austrian Pine	4	28.0	3	poor; DTB
4	abies balsamea	Balsam Fir	16	25-35	3.5	good
	acer platanoides	Norway Maple	4	30.0	3.5	good; surface roots; TS
5	fraxinus americana	White Ash	2	15,30	3.5	fair; 30% dieback
	acer saccharum	Sugar Maple	3	12-20	4.5	good
6	larix laricina	Tamarack	1	35.0	4.0	good
7	acer saccharum	Sugar Maple	1	18.0	3.0	good
	acer platanoides	Norway Maple	1	22.0	4.0	good; fungus/lichen
8	abies balsamea	Balsam Fir	6	30-35	3.5	good; clumped
9	picea pungens	Colorado Spruce	9	30-35	3.5	good
10	abies balsamea	Balsam Fir	2	25-30	3.5	good; some branches damaged
11	pinus nigra	Austrian Pine	7	35-40	6.0	fair; 30% dieback

acer saccharinum	Silver Maple	1	60.0	8.0	good
12	acer saccharinum	Silver Maple	1	50.0	7.0	good
13	abies balsamea	Balsam Fir	3	30-45	3.5	good
14	acer platanoides	Norway Maple	2	30.0	5.0	good; TS
15	acer saccharinum	Silver Maple	4	20-26	5.5	good; one has trunk damage
16	abies balsamea	Balsam Fir	8	25-30	3.5	good;
	pinus nigra	Austrian Pine	2	30-35	4.0	good
17	picea pungens	Colorado Spruce	7	30-35	3.5	good
18	abies balsamea	Balsam Fir	4	25-30	3.5	good;
	pinus nigra	Austrian Pine	4	30-35	4.0	good
19	picea pungens	Colorado Spruce	3	30-35	3-4	2 good; 1 poor
	fraxinus americana	White Ash	3	20.0	2.5	good; trunk damage
20	acer saccharinum	Silver Maple	3	15-18	2.5	good
	acer platanoides	Norway Maple	2	15-22	2.5	good; 2 succoring
21	abies balsamea	Balsam Fir	14	15.0	2.5	good; fence row
22	acer saccharinum	Silver Maple	3	20.0	3.5	good
23	acer platanoides	Norway Maple	1	15.0	2.5	fair; stunted growth
24						
25

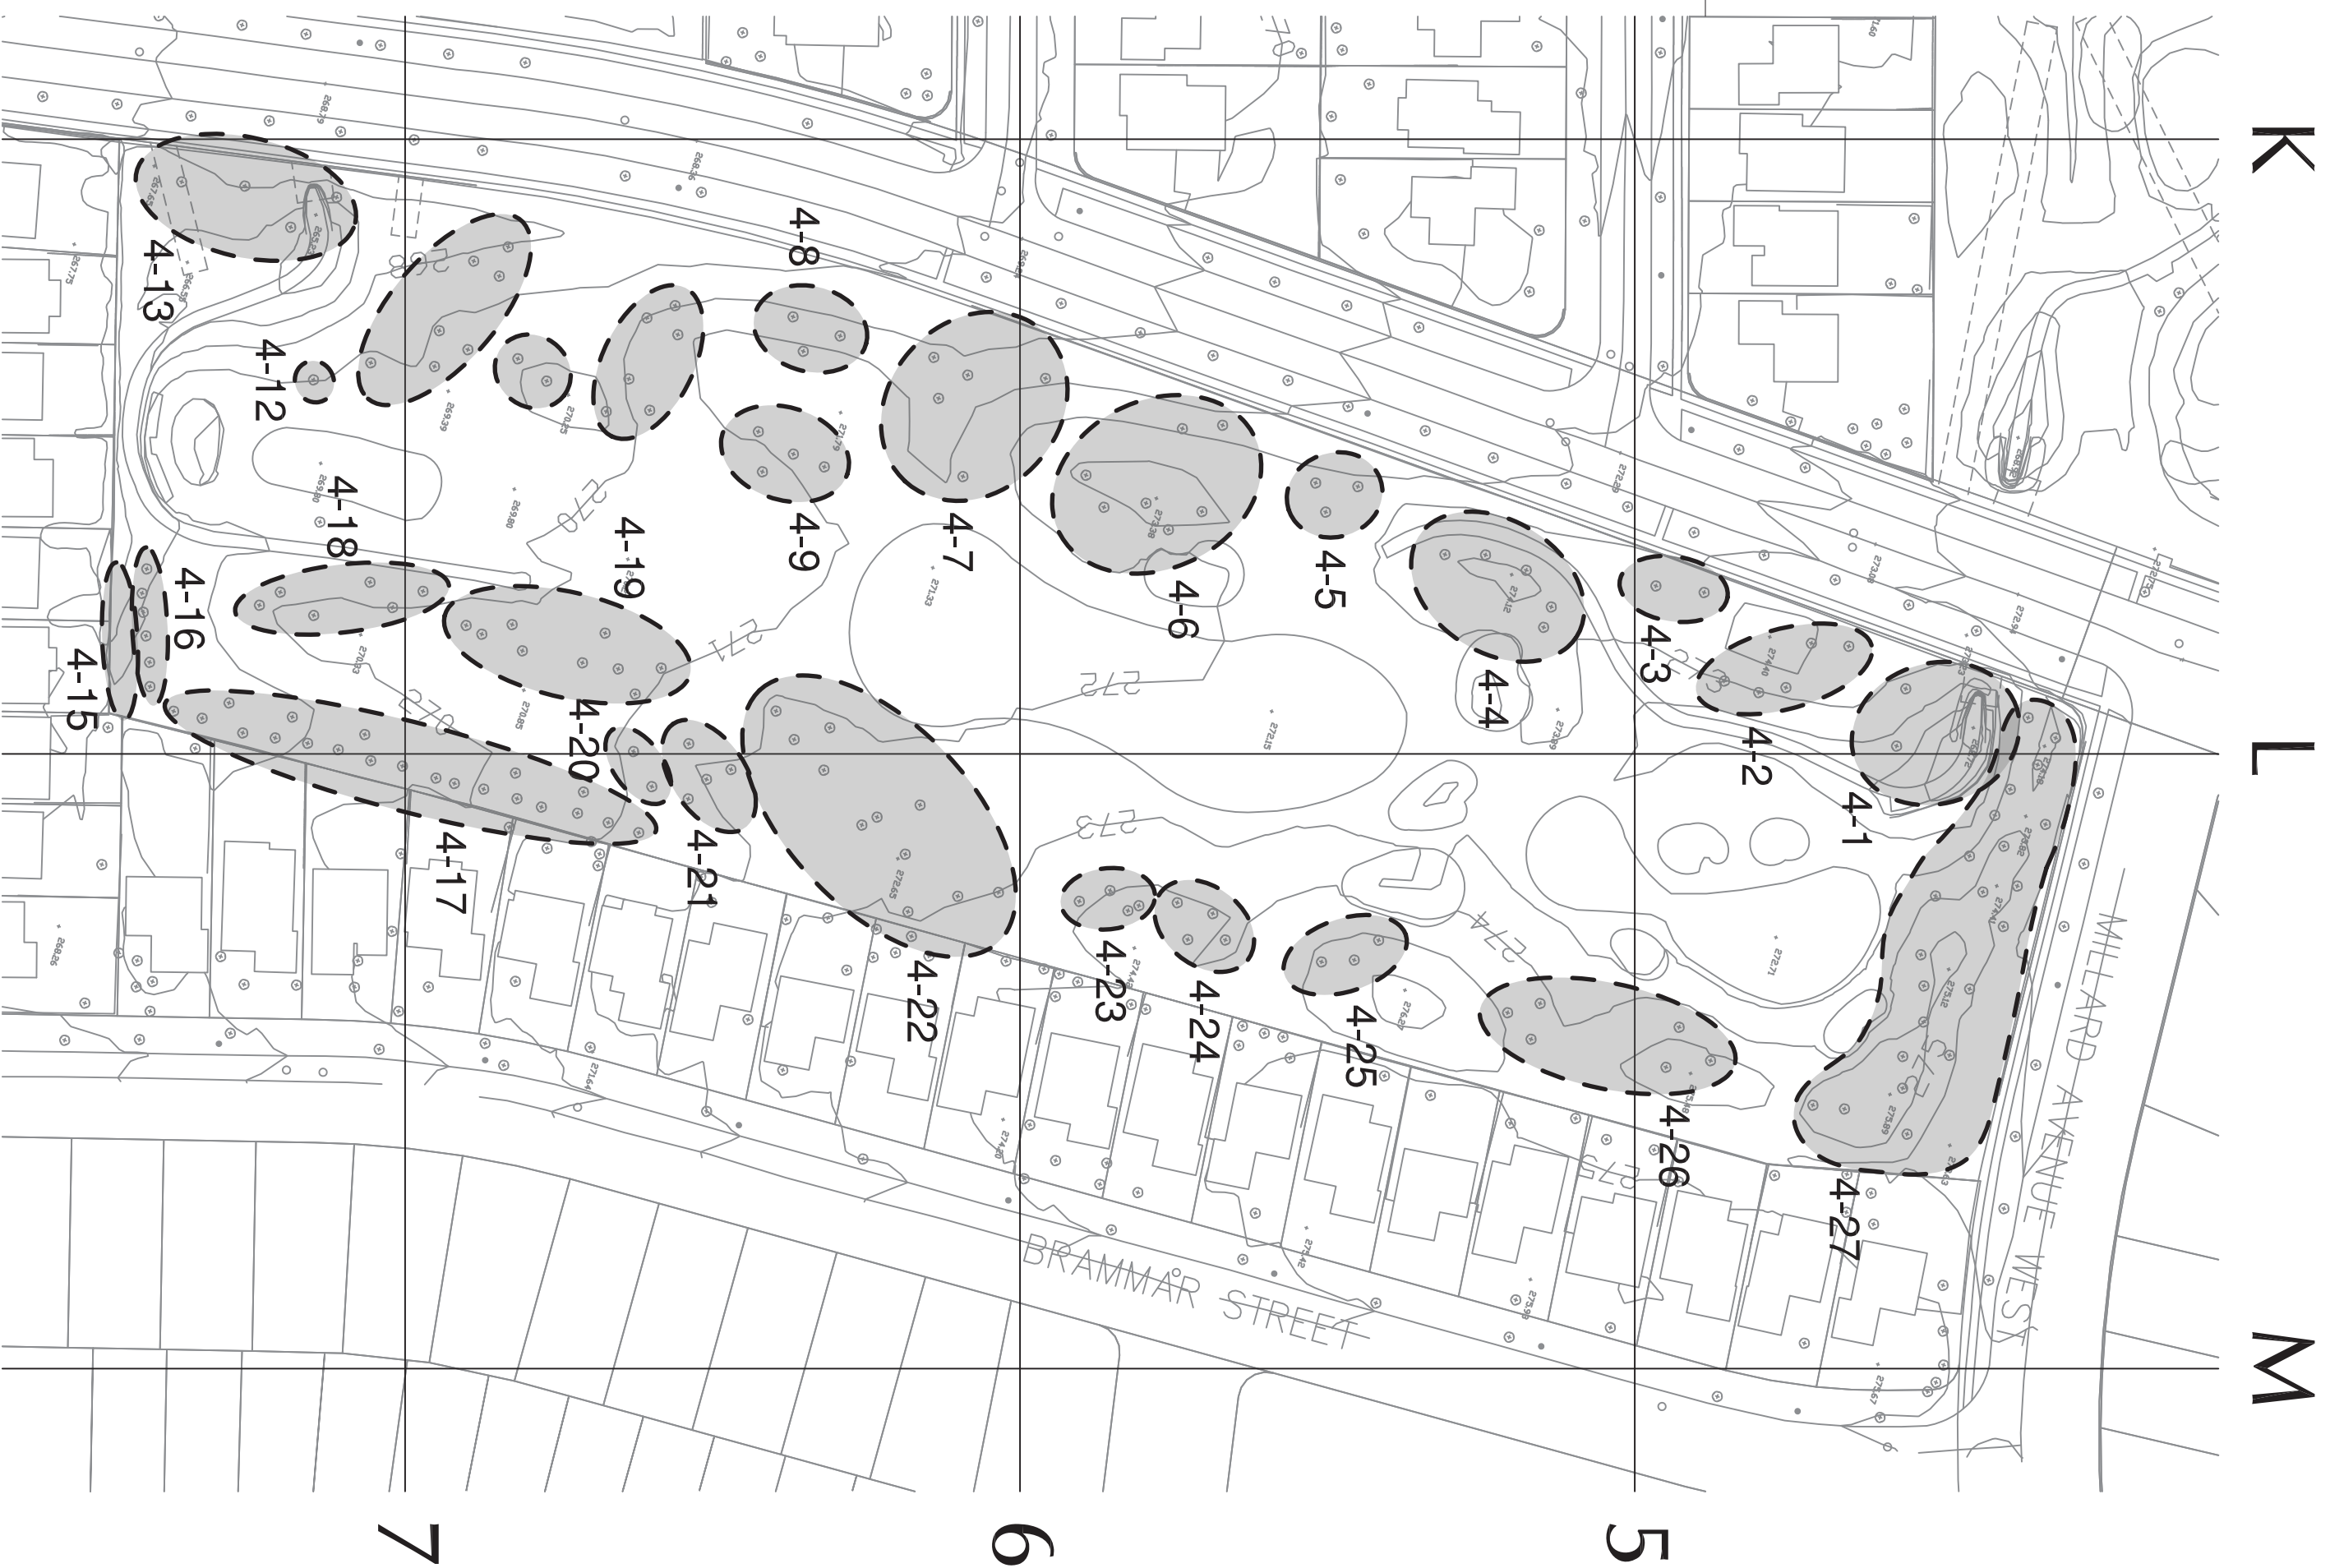
2 Hole 4 Plan Scale 1:1000

Tree No.	Species Botanical Name	Common Name	Qty	Size DBH (cm)	radius (m)	Condition
1	pinus nigra	Austrian Pine	6	30-35	3.0	good
	acer platanoides	Norway Maple	2	8.0	2.5	good
2	acer saccharinum	Silver Maple	5	25-35	3.5	good; surface roots;
3	fraxinus americana	White Ash	2	25.0	3-4.5	good; fungus/lichen; frost damage
4	pinus nigra	Austrian Pine	4	30-35	3.0	good; minor dieback
5	fraxinus americana	White Ash	3	18.0	3.0	good
6	acer platanoides	Norway Maple	6	18-30	33.5	good;TS
	acer saccharum	Sugar Maple	1	18.0	2.5	good
7	acer saccharum	Sugar Maple	1	25.0	3.0	good; trunk damage
	acer saccharinum	Silver Maple	1	25.0	3.5	good
	fraxinus americana	White Ash	3	25-35	3.0	good
8	acer platanoides	Norway Maple	3	25-35	40667.0	good; TS
9	picea pungens	Colorado Spruce	4	30-35	3.5	good; one leaning
10	fraxinus americana	White Ash	3	21.0	3.0	good
	acer saccharinum	Silver Maple	3	25.0	3.5	good
11	pinus nigra	Austrian Pine	2	30.0	3.0	poor; misshapen

12	acer saccharinum	Silver Maple	7	20-25	4.5	good; 3 succoring
13	acer platanoides	Norway Maple	4	15-30	3-4.5	good; TS
14	picea pungens	Colorado Spruce	1	30.0	5.0	good
15	acer ginnala	Amur Maple	6	multistem		good; mature ht
16	abies balsamea	Balsam Fir	5	25-30	3.5	good;
	fraxinus americana	White Ash	1	20.0	4.0	good
17	abies balsamea	Balsam Fir	15	12.0	2.0	good; hedgerow on fence
	fraxinus americana	White Ash	6	20.0	4.0	good
18	acer saccharinum	Silver Maple	3	15-20	3.0	good; 3 succoring
	pinus nigra	Austrian Pine	3	20-30	4.0	good; DTB
19	acer saccharinum	Silver Maple	6	12-15	2.5	good; 3 succoring
	pinus nigra	Austrian Pine	3	25-30	4.0	2 good; 1 fair
20	abies balsamea	Balsam Fir	2	30.0	2.5	good
	picea pungens	Colorado Spruce	4	30-35	3.5	good
21	pinus nigra	Austrian Pine	3	30-35	3.0	1 good; 2 poor
	picea pungens	Colorado Spruce	1	30.0	3.5	good
22	fraxinus americana	White Ash	4	30-35	8.0	3 good; 1 poor
	acer platanoides	Norway Maple	6	26.0	3.0	good; TS

23	pinus nigra	Austrian Pine	2	18,30	4.5	1 good; 1 poor
	picea pungens	Colorado Spruce	1	35.0	4.5	good

24	acer saccharinum	Silver Maple	4	12-22	4.5	good; all succoring
25	picea pungens	Colorado Spruce	3	30-35	3.5	good
26	acer saccharinum	Silver Maple	3	25	3	good
	acer saccharum	Sugar Maple	3	20-25	5.5	good; succoring
27	pinus nigra	Austrian Pine	9	30-38	5	7 good; 2 poor
	picea pungens	Colorado Spruce	11	30-35	5	10 good; 1 poor
	acer platanoides	Norway Maple	2	33	5	good; TS
