Estates of Glenway

Tree Inventory Report

Project:
Marianneville Developments Ltd.
 Newmarket, Ontario, Canada

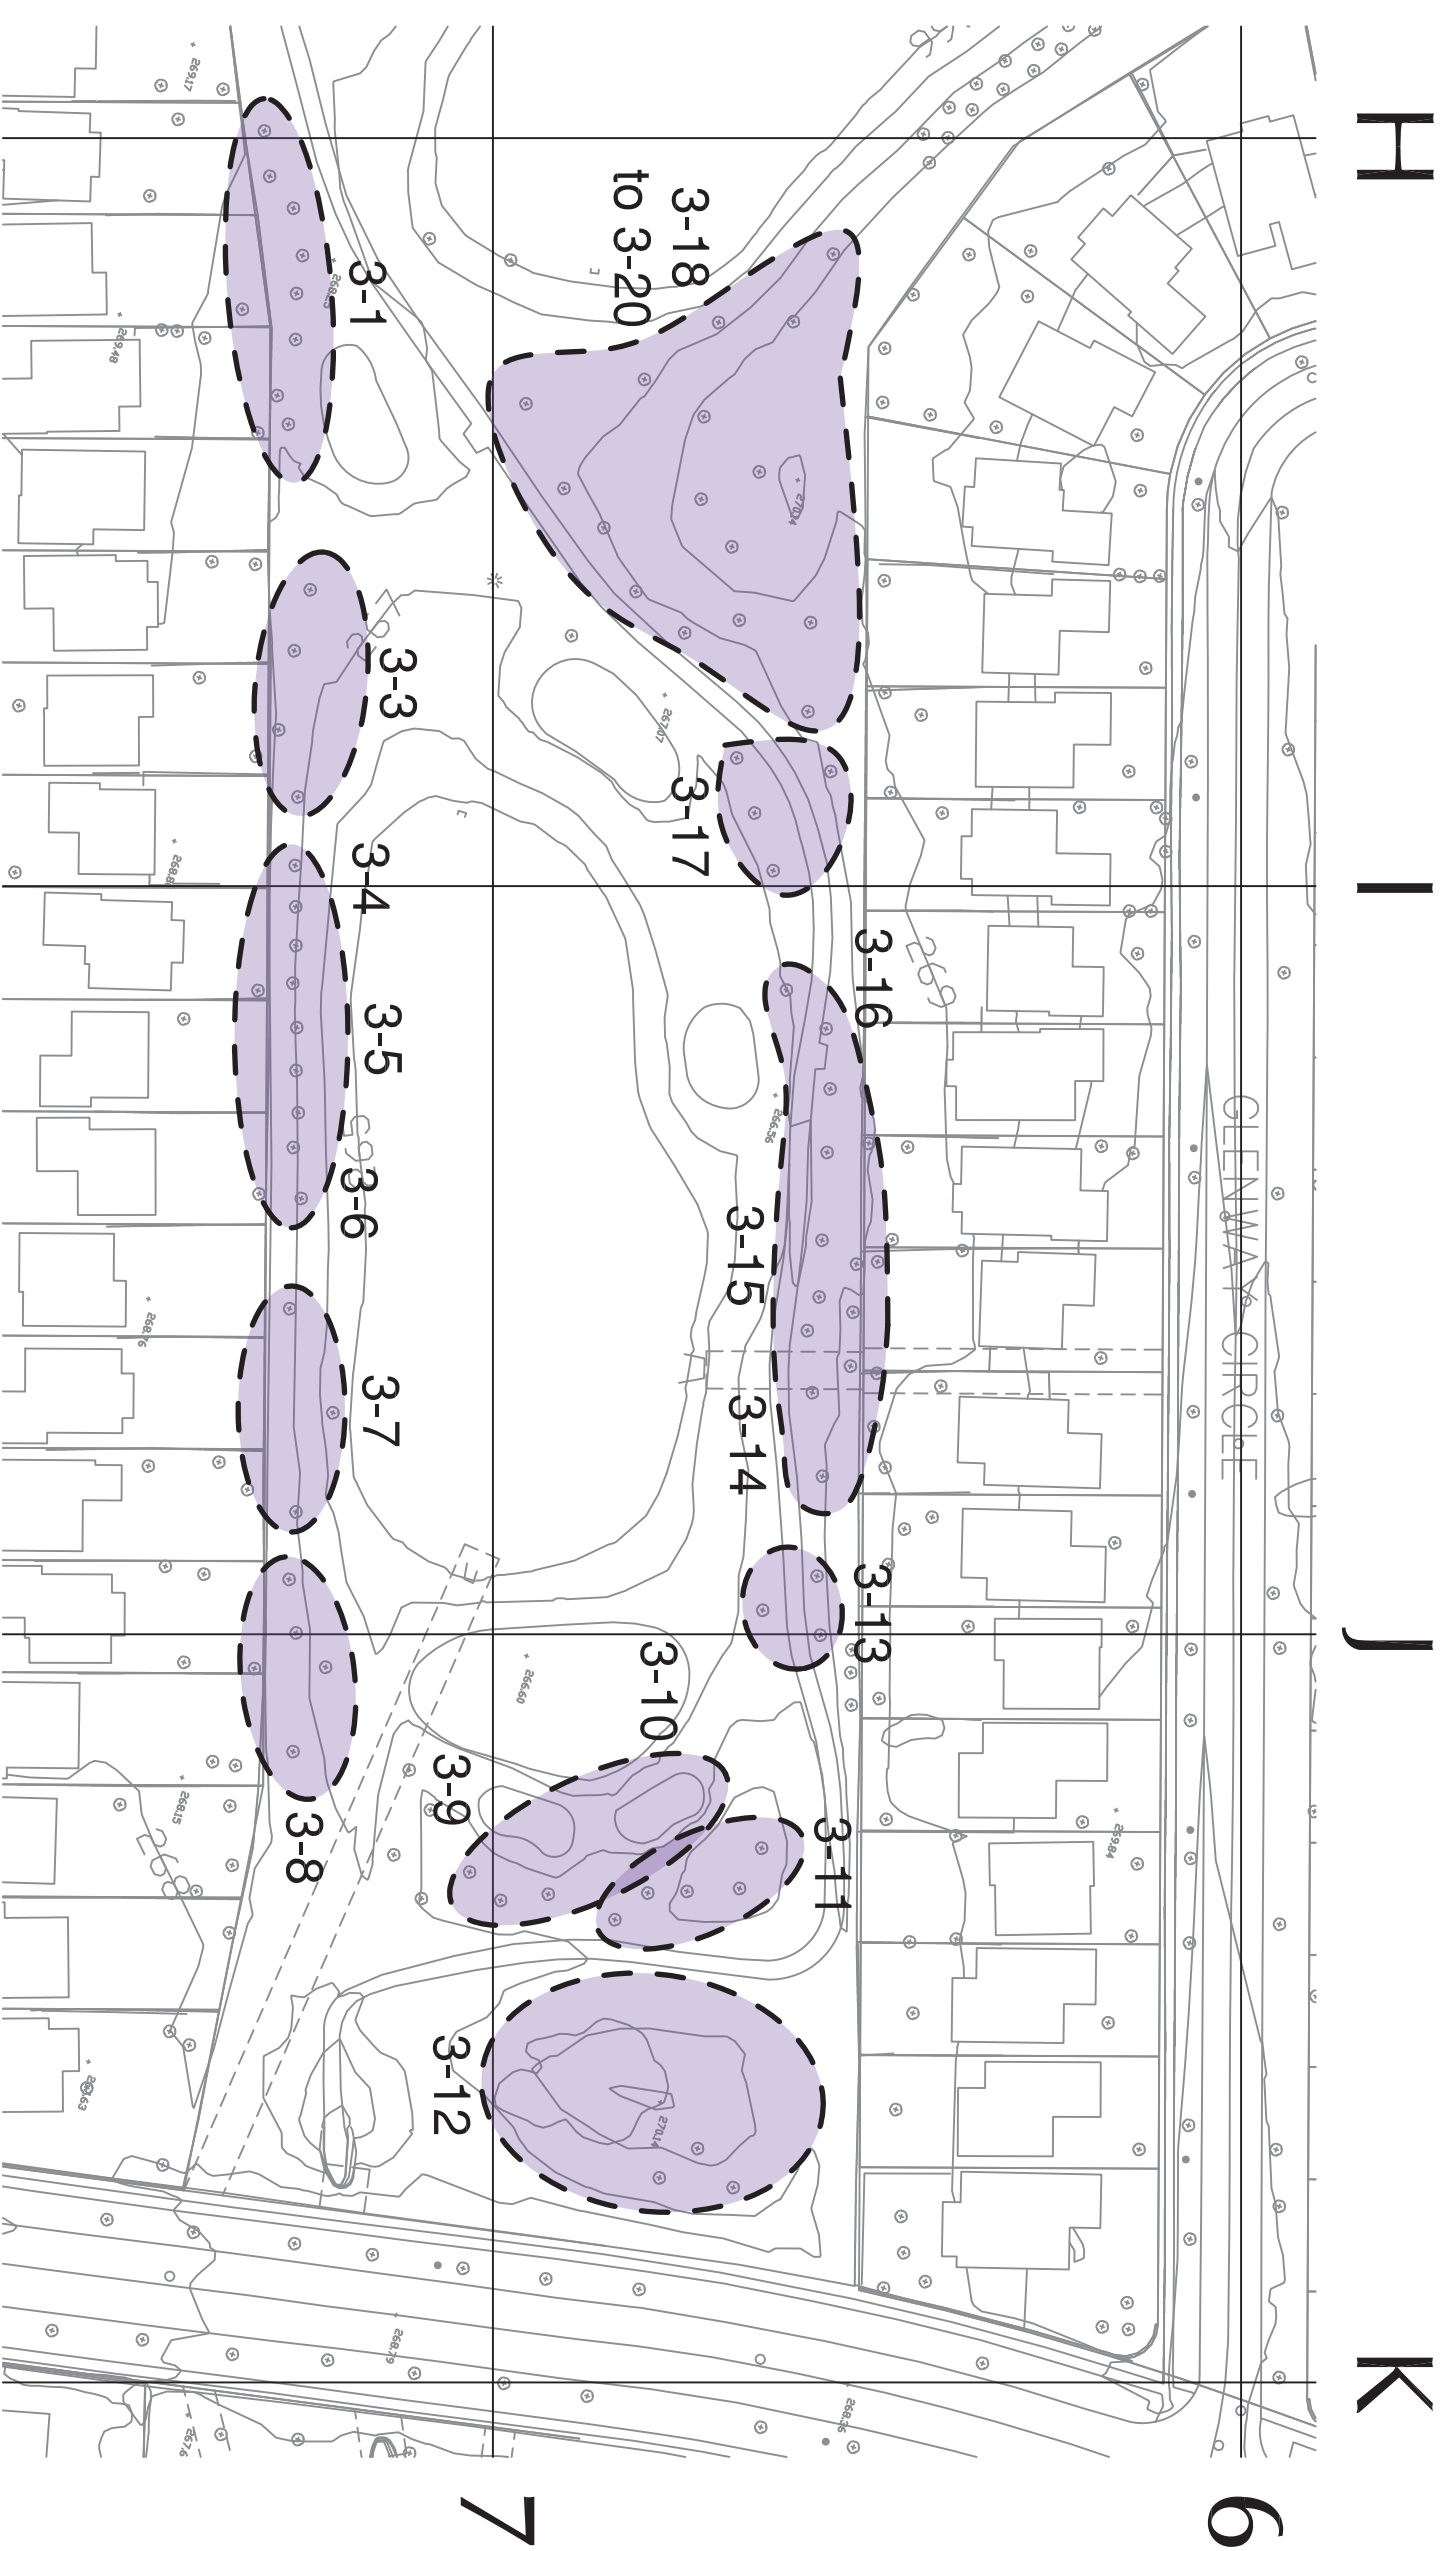
1 Hole 3 Plan Scale 1:1000

Tree No.	Species Botanical Name	Common Name	Qty	Size DBH (cm)	radius (m)	Condition
1	abies balsamea	Balsam Fir	3	5m ht	2.0	good
	picea pungens	Colorado Spruce	2	30.0	2.5	good
2	picea omorika	Serbian Spruce	3	3m ht	1m	good
3	abies balsamea	Balsam Fir	4	35.0	3-4.5	good
4	abies balsamea	Balsam Fir	1	15.0	2.0	good
	picea omorika	Serbian Spruce	3	15.0	2.0	good
5	abies balsamea	Balsam Fir	1	15.0	2.0	good
	picea pungens	Colorado Spruce	2	15.0	2.0	good
6	fraxinus americana	White Ash	1	20.0	3.0	good
7	betula pendula	European Birch	2	30,35	3.0	1 good; 1 poor
8	picea pungens	Colorado Spruce	2	30-35	3.5	good
	abies balsamea	Balsam Fir	2	30-35	3.5	good
9	abies balsamea	Balsam Fir	3	30.0	3.5	2 good; 1 poor 40% dieback
	fraxinus americana	White Ash	1	12.0	3.0	good
10	acer platanoides	Norway Maple	1	18.0	3.0	good
	acer saccharinum	Silver Maple	2	12,25	2-3.5	good; succoring
11	pinus nigra	Austrian Pine	2	30.0	3.0	good
	acer platanoides	Norway Maple	3	30.0	6.0	good; surface roots

12	pinus nigra	Austrian Pine	7	30-35	5.0	6 good; 1 poor
	picea pungens	Colorado Spruce	3	35.0	5.0	good
13	pinus nigra	Austrian Pine	3	30-38	3-4.5	good
14	abies balsamea	Balsam Fir	3	30-35	5.0	2 good; 1 poor 40% dieback
	pinus nigra	Austrian Pine	3	35.0	4.5	2 good; 1 fair DTB
15	abies balsamea	Balsam Fir	2	35.0	3.0	good
	picea pungens	Colorado Spruce	1	30.0	2.5	good
16	abies balsamea	Balsam Fir	2	25-30	3.5	good; 1 leaning
17	picea pungens	Colorado Spruce	1	20.0	2.5	good
	fraxinus americana	White Ash	3	20.0	4.0	good
18	pinus nigra	Austrian Pine	5	30-38	3-4.5	good
	fraxinus americana	White Ash	2	15-20	4.0	good
19	picea pungens	Colorado Spruce	4	30-35	3.5	good
	acer platanoides Schwedleri	Schwedler Maple	1	18.0	2.5	good
20	betula pendula	European Birch	3	25-35	3.5	1 good; 1 fair; 1 poor
	abies balsamea	Balsam Fir	1	30.0	3.5	good
21

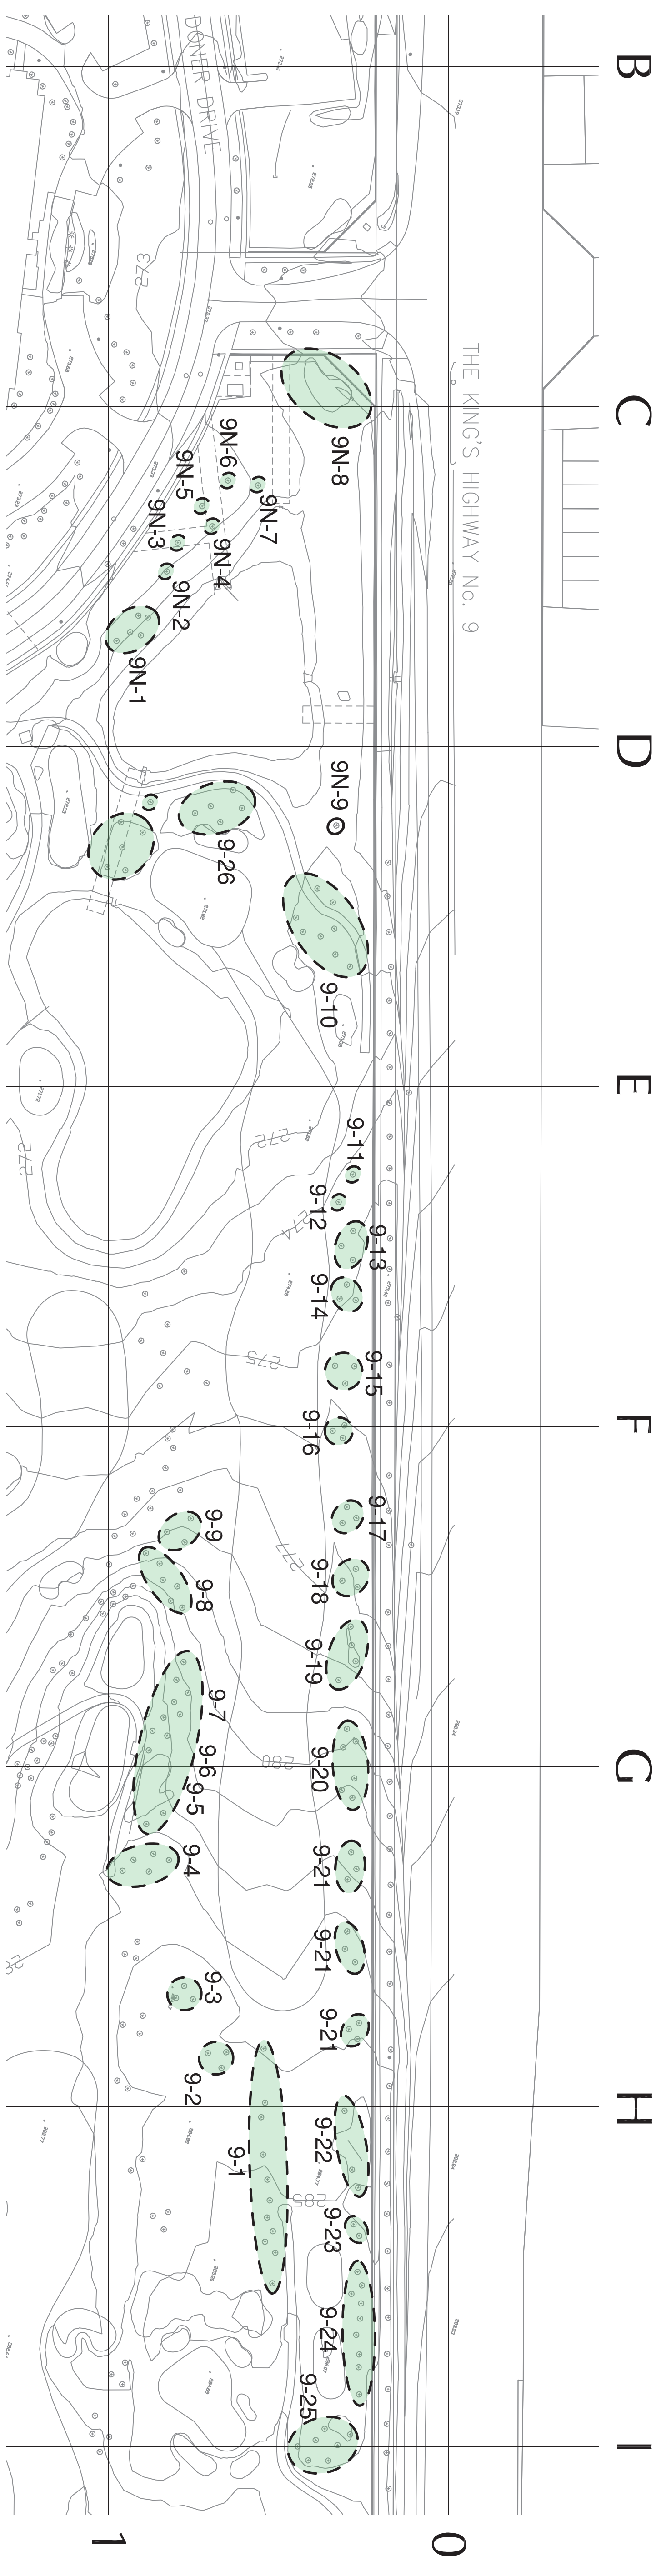
2 Hole 9 Plan scale: 1:1000

Tree No.	Species Botanical Name	Common Name	Qty.	Size DBH (cm)	radius (m)	Condition
1	acer platanoides Schwedleri	Schwedler Maple	5	12 - 15	2.5	4 good; one poor with trunk damage; TS
2						
3						
4	acer platanoides	Norway Maple	1	18	3.5	good; TS; fungus on trunk
5	fraxinus americana	White Ash	1	15	2.5	good
6	fraxinus americana	White Ash	1	15	2.5	good
7	acer platanoides	Norway Maple	1	12	2	poor; 25% dieback
8	acer platanoides	Norway Maple	3	15-28	4-5	fair; frost crack; fungus
	picea pungens	Colorado Spruce	3	15 - 25	2-3	poor; 25% dieback
9	picea pungens	Colorado Spruce	1	10&20	2.5	poor double trunk; 50% dieback
10	pinus nigra	Austrian Pine	6	25	4	fair; 20% dieback; DTB
	acer platanoides	Norway Maple	2	15-20	4	fair; two branches dead; TS
11	acer saccharum	Sugar Maple	1	15	2.5	fair; fungus/lichen; pruned to 3m
12	fraxinus americana	White Ash	1	15	4	good
13	acer saccharum	Sugar Maple	3	12-18	3.5	fair; road salt damage; pruned to 3m

14	pinus nigra	Austrian Pine	3	20 - 25	3	fair; DTB
15	acer platanoides	Norway Maple	3	dbl trunk	3	fair; dbl trunk; one trunk damaged; pruned to 3m
16	pinus nigra	Austrian Pine	3	20 - 25	3	fair; DTB
17	pinus nigra	Austrian Pine	3	20 - 25	3	fair; DTB
18	acer platanoides	Norway Maple	3	20 - 25	2-4	poor; TS; caterpillars; frost crack; trunk damage
19	pinus nigra	Austrian Pine	4	20 - 25	3	fair; DTB
20	acer platanoides	Norway Maple	6	20 - 25	2-4	5 good; 1 poor; TS; surface roots
21	pinus nigra	Austrian Pine	9	22-28	2-3	fair; DTB; one stunted; one has 50% dieback
22	picea pungens	Colorado Spruce	3	20-30	2.5	fair; leaning; 10% dieback
23	pinus nigra	Austrian Pine	2	22-28	2-3	fair; DTB; one has 20% dieback
24	pinus nigra	Austrian Pine	5	25	2-3	fair; DTB; one has 20% dieback
	picea pungens	Colorado Spruce	4	20-35	2.5-3.5	fair; leaning; 10% dieback; pruned to 1m
25	picea pungens	Colorado Spruce	7	25-30	2.5-3.5	fair; 10% dieback; one missing leader

26	acer platanoides	Norway Maple	6	25-30	4	5 good; 1 poor; TS; surface roots
27	betula pendula	European Birch	1	20	2	fair; trunk damage; surface roots; insect damage
28	chamaecyparis nootkatensis	Nootka False Cypress	1	10	6m ht	good
	picea pungens	Colorado Spruce	4	25-35	02-Apr	2 good; 2 poor with 30% dieback

Tree No.	Species Botanical Name	Common Name	Qty.	Size DBH (cm)	radius (m)	Condition
1	picea abies	Balsam Fir	11	35	3.5	10 good; 1 poor
2	acer saccharinum	Silver Maple	3	12 - 15	3	fair; fungus/lichen on trunk; one leaning; succoring; 10% dieback
3	picea pungens	Colorado Spruce	3	25	2.5	good
4	picea abies	Balsam Fir	2	25	3	good
	pinus nigra	Austrian Pine	3	25 - 30	3	fair; 20% dieback; DTB
5	acer ginnala	Amur Maple	4	5-7m ht		good
	picea abies	Balsam Fir	2	20-25	3	good
6	fraxinus americana	White Ash	2	25 - 30	4.5	good; insect damage on trunk; 10% dieback
	picea pungens	Colorado Spruce	3	22 - 30	4.5	good
7	acer platanoides Crimson King	Crimson King Maple	4	18 - 25	3	good; frost crack on one; pruned high; orange fungus; TS; surface roots
	pinus nigra	Austrian Pine	2	20 - 25	2.5	poor; one leaning; 30% dieback; DTB
8	acer saccharinum	Silver Maple	6	15 - 25	3.5 - 4.5	good; 10% dieback
9	picea pungens	Colorado Spruce	3	20 - 25	2.5	good

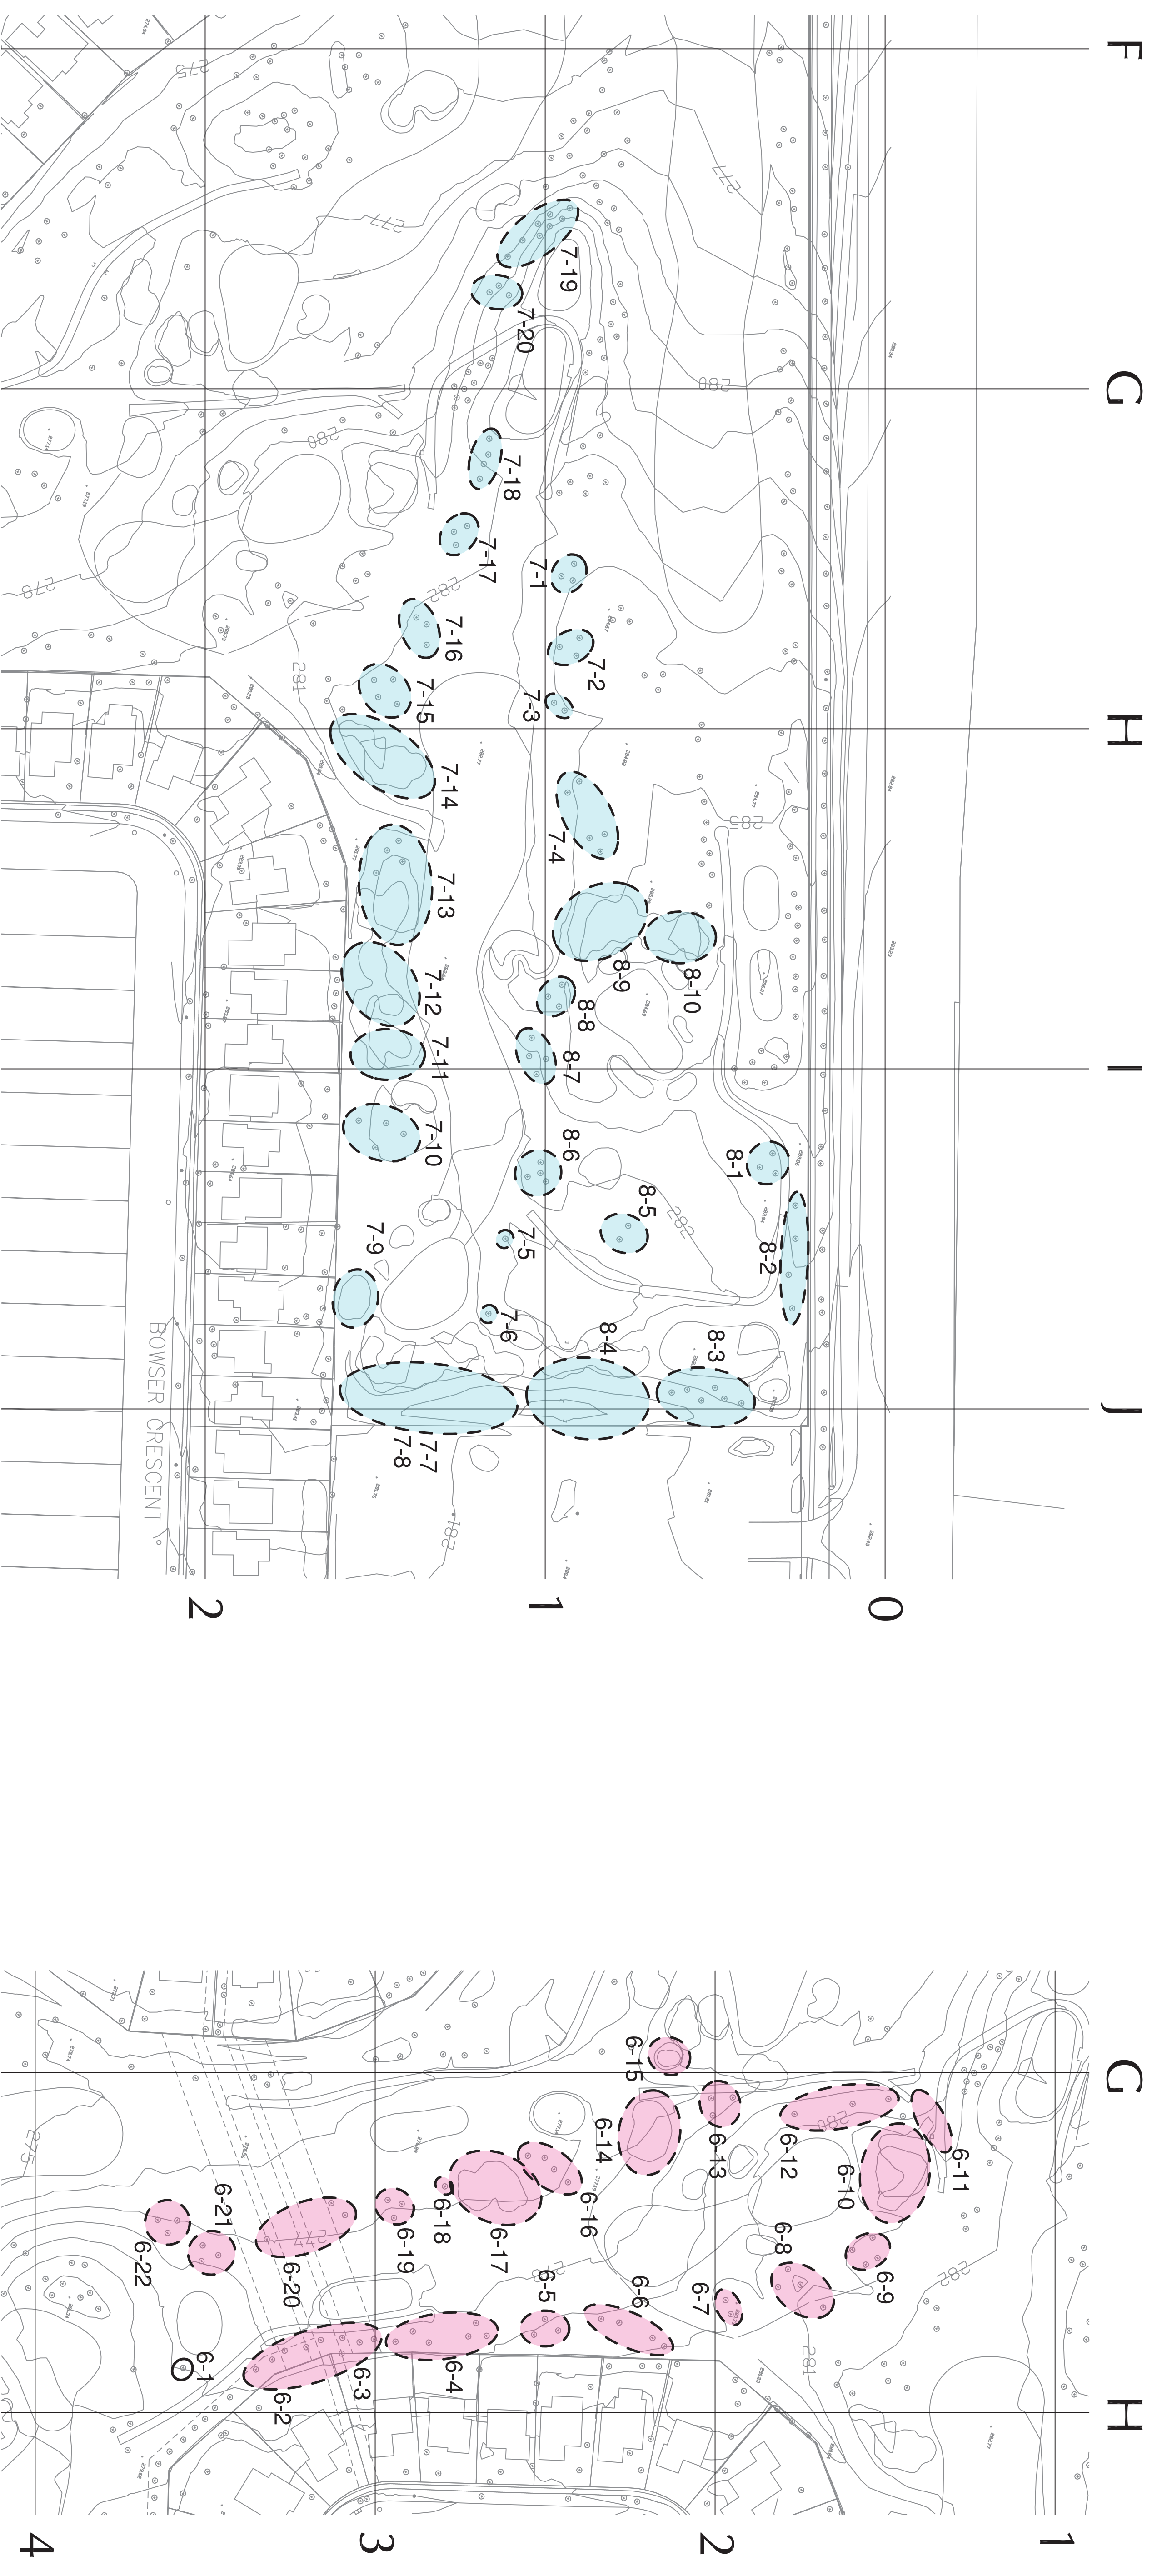
2 Hole 7 & 8 Plan scale: 1:1000

Tree No.	Species Botanical Name	Common Name	Qty	Size DBH (cm)	radius (m)	Condition
1	acer platanoides	Norway Maple	3	20	3	good; TS; fungus; surface roots
2	acer saccharinum	Silver Maple	3	12-18	3	good: surface roots
3	acer saccharum	Sugar Maple	2	15-20	3.5	good; fungus
4	acer saccharinum	Silver Maple	3	12-18	3	good: surface roots; one is succoring
5	acer platanoides	Norway Maple	3	25-28	3.5	good; TS; fungus; surface roots
6	acer saccharinum	Silver Maple	1	35	4	good
7	pinus nigra	Austrian Pine	13	25-35	3.5	4 good; 5 fair; 4 poor
8	picea pungens	Colorado Spruce	5	25-35	3.5	good; dense group
9	pinus nigra	Austrian Pine	2	35-45	4.5	good; dense group; DTB
10	abies balsamea	Balsam Fir	2	35	3.5	good
	acer platanoides	Norway Maple	2	25	3.5	good; tS; fungus; surface roots; trunk flare
11	pinus nigra	Austrian Pine	4	30 - 40	3.5	2 good; 2 fair - dead leader 40% dieback
	abies balsamea	Balsam Fir	4	30	3.5	good
12	abies balsamea	Balsam Fir	6	20-35	3-4	good

acer platanoides	Norway Maple	4	20-35	2.5	good; tS; fungus; surface roots; trunk flare
13	acer platanoides Crimson King	Crimson King Maple	1	18	2.5	good; tS; fungus; surface roots; trunk flare
	fraxinus americana	White Ash	1	24	3.5	fair; 10% dieback; insects on leaves
14	abies balsamea	Balsam Fir	7	25-35	3-4	good
	pinus nigra	Austrian Pine	2	35	3.5	good; 20% dieback
15	acer saccharinum	Silver Maple	4	12-20	2-4.5	good; one succoring; one with tree cavity
16	fraxinus americana	White Ash	3	15-22	2-2.5	fair: leaning; insect damage; trunk damage; 20% dieback
17	acer ginnala	Amur Maple	3	6m ht		good
18	abies balsamea	Balsam Fir	4	25-30	1.5	good
19	abies balsamea	Balsam Fir	7	15-22	3-4	good
	acer platanoides Crimson King	Crimson King Maple	1	Jan-00	3.5	good; located on slope
20	acer saccharinum	Silver Maple	3	30-35	3.5	good; two succoring
21						
22						
23						
24						
25

Tree No.	Species Botanical Name	Common Name	Qty	Size DBH (cm)	radius (m)	Condition
1	acer platanoides	Norway Maple	3	25-35	3-3.5	good; TS; fungus; surface roots
2	picea pungens	Colorado Spruce	3	30-35	2.5	good; one has 10% dieback
	pinus nigra	Austrian Pine	2	35	3	good
3	abies balsamea	Balsam Fir	3	8-20	30	good
	pinus nigra	Austrian Pine	3	24-30	2.5-3.5	one good; one poor due to DTB, 40% dieback
4	picea pungens	Colorado Spruce	4	30-35	2.5	3 good; one poor
	pinus nigra	Austrian Pine	3	24-30	3	2 good; 2 fair - leaning and DTB
5	fraxinus americana	White Ash	2	25	4.5	one good; one has trunk cavity at first branch - fair
6	picea pungens	Colorado Spruce	1	28	3	good
	pinus nigra	Austrian Pine	3	24-30	3.5	poor; 50% dieback
7	thuja occidentalis	White Cedar	4	10m ht		good
8	acer saccharinum	Silver Maple	3	25 -30	6	good; 20% dieback on one
9	picea pungens	Colorado Spruce	10	30-35	3	good
	pinus nigra	Austrian Pine	5	30	3.5	good; dense group

10	acer platanoides Schwedleri	Schwedler Maple	1	25	3	good
	acer ginnala	Amur Maple	2	multi-stem	6m ht	good
11	pinus nigra	Austrian Pine	4	30 - 40		healthy but leaning
12						
13						
14						
15						
16						
17						
18						
19						
20						
21						
22						
23						
24						
25

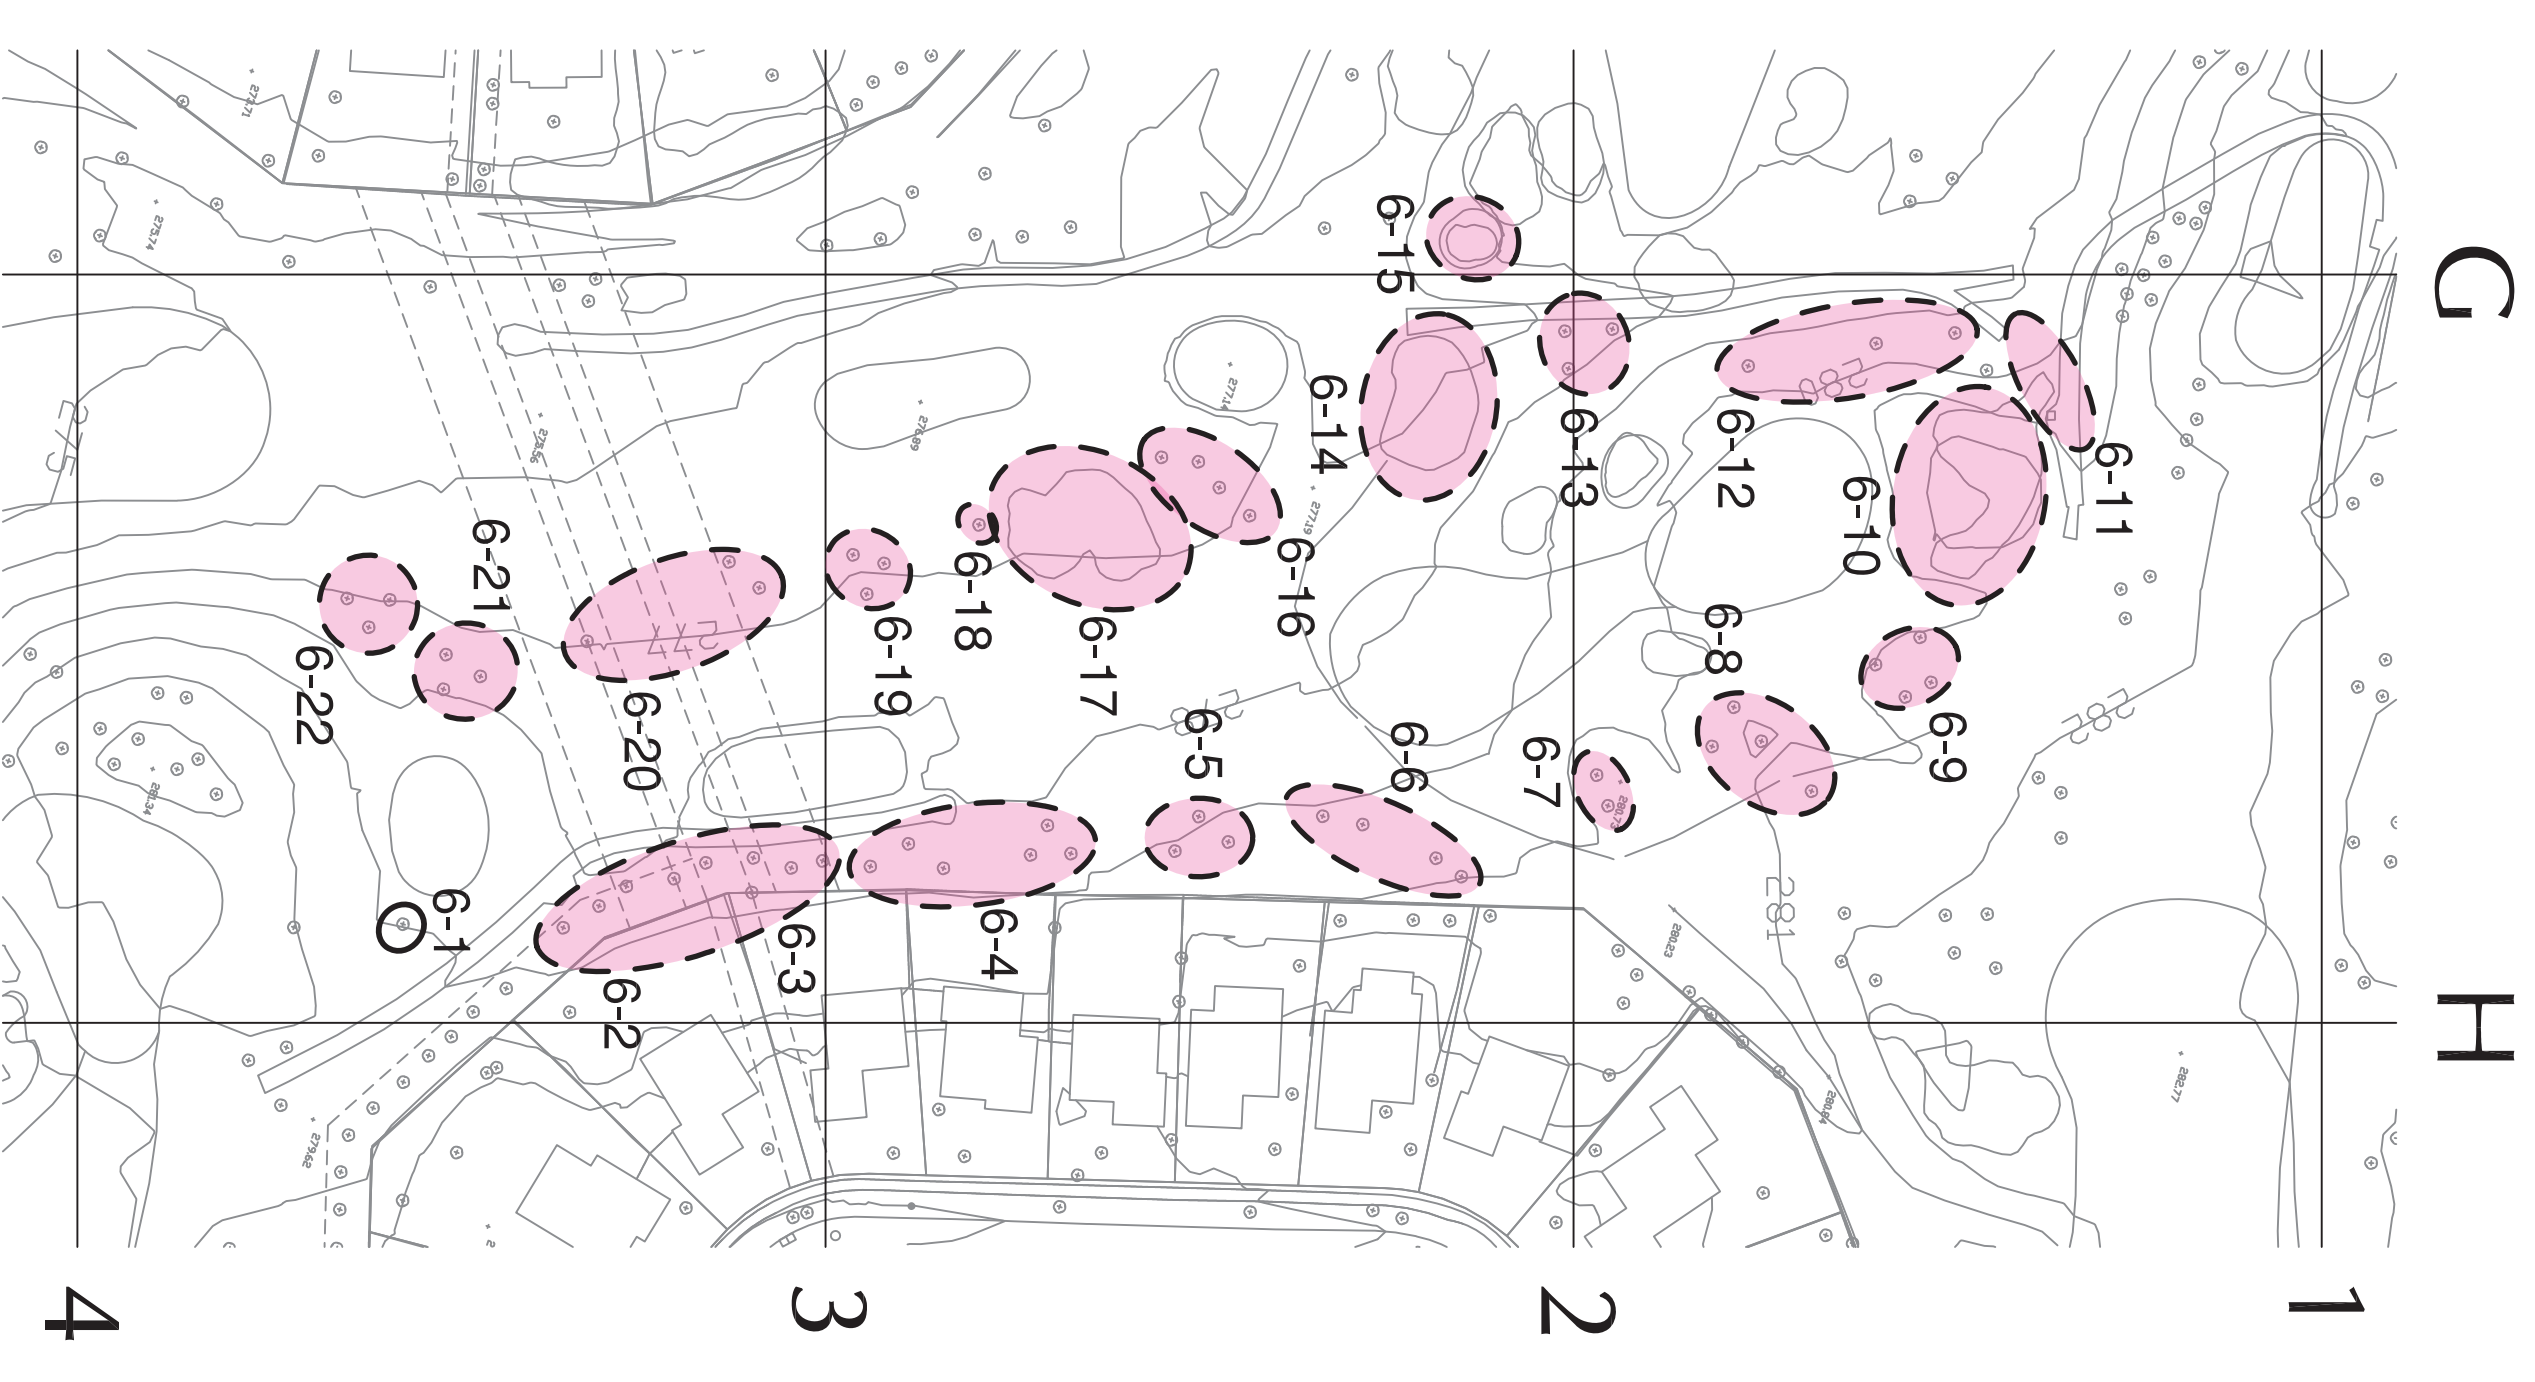
1 Hole 6 Plan scale: 1:1000

Tree No.	Species Botanical Name	Common Name	Qty	Size DBH (cm)	radius (m)	Condition
1	fraxinus americana	White Ash	1	25.0	3.0	good
2	fraxinus americana	White Ash	2	25.0	3.0	one poor; one good
3	picea pungens	Colorado Spruce	1	30	3.5	good
	pinus nigra	Austrian Pine	2	25-35	3	1 good; 1 fair - leaning
4	picea pungens	Colorado Spruce	3	25-35	3.5	good
	pinus nigra	Austrian Pine	3	25-35	3	2 good; 1 fair - dense group
5	picea pungens	Colorado Spruce	3	25-28	3.5	good
6	acer saccharinum	Silver Maple	2	25.0	4.0	good
	abies balsamea	Balsam Fir	1	25.0	3.5	good
	acer platanoides	Norway Maple	1	25.0	3.5	good
7	pinus nigra	Austrian Pine	2	30	3.5	1 good; 1 poor
8	acer platanoides	Norway Maple	4	30-35	3.5	good; TS; roots exposed
9	pinus nigra	Austrian Pine	3	35.0	3.5	1 good; 2 fair DTB
10	picea pungens	Colorado Spruce	4	35.0	3.5	good
	pinus nigra	Austrian Pine	3	35.0	4.5	good
11	thuja occidentalis	White Cedar	6	3m ht		good

12	acer platanoides	Norway Maple	4	22.0	2.5	good; TS
13	acer saccharinum	Silver Maple	3	25.0	3.0	good
14	crataegus punctata	Dotted Hawthorn	10	multi-stem		original farm hedgerow; declining
15	abies balsamea	Balsam Fir	2	25.0	3.5	good
16	picea pungens	Colorado Spruce	4	30-35	2-2.5	good
17	pinus nigra	Austrian Pine	4	30-35	3.0	3 good; 1 fair - multistem, no leader
18	acer platanoides	Norway Maple	1	25.0	3.5	good; TS
19	picea pungens	Colorado Spruce	3	30-35	3-4	good
20	acer saccharinum	Silver Maple	3	25-30	3.5	good; two succoring
21	pinus nigra	Austrian Pine	3	25-30	3.0	2 good; 1 fair - dense group
22	acer saccharinum	Silver Maple	3	15-25	3.5	good; one succoring
23						
24						
25

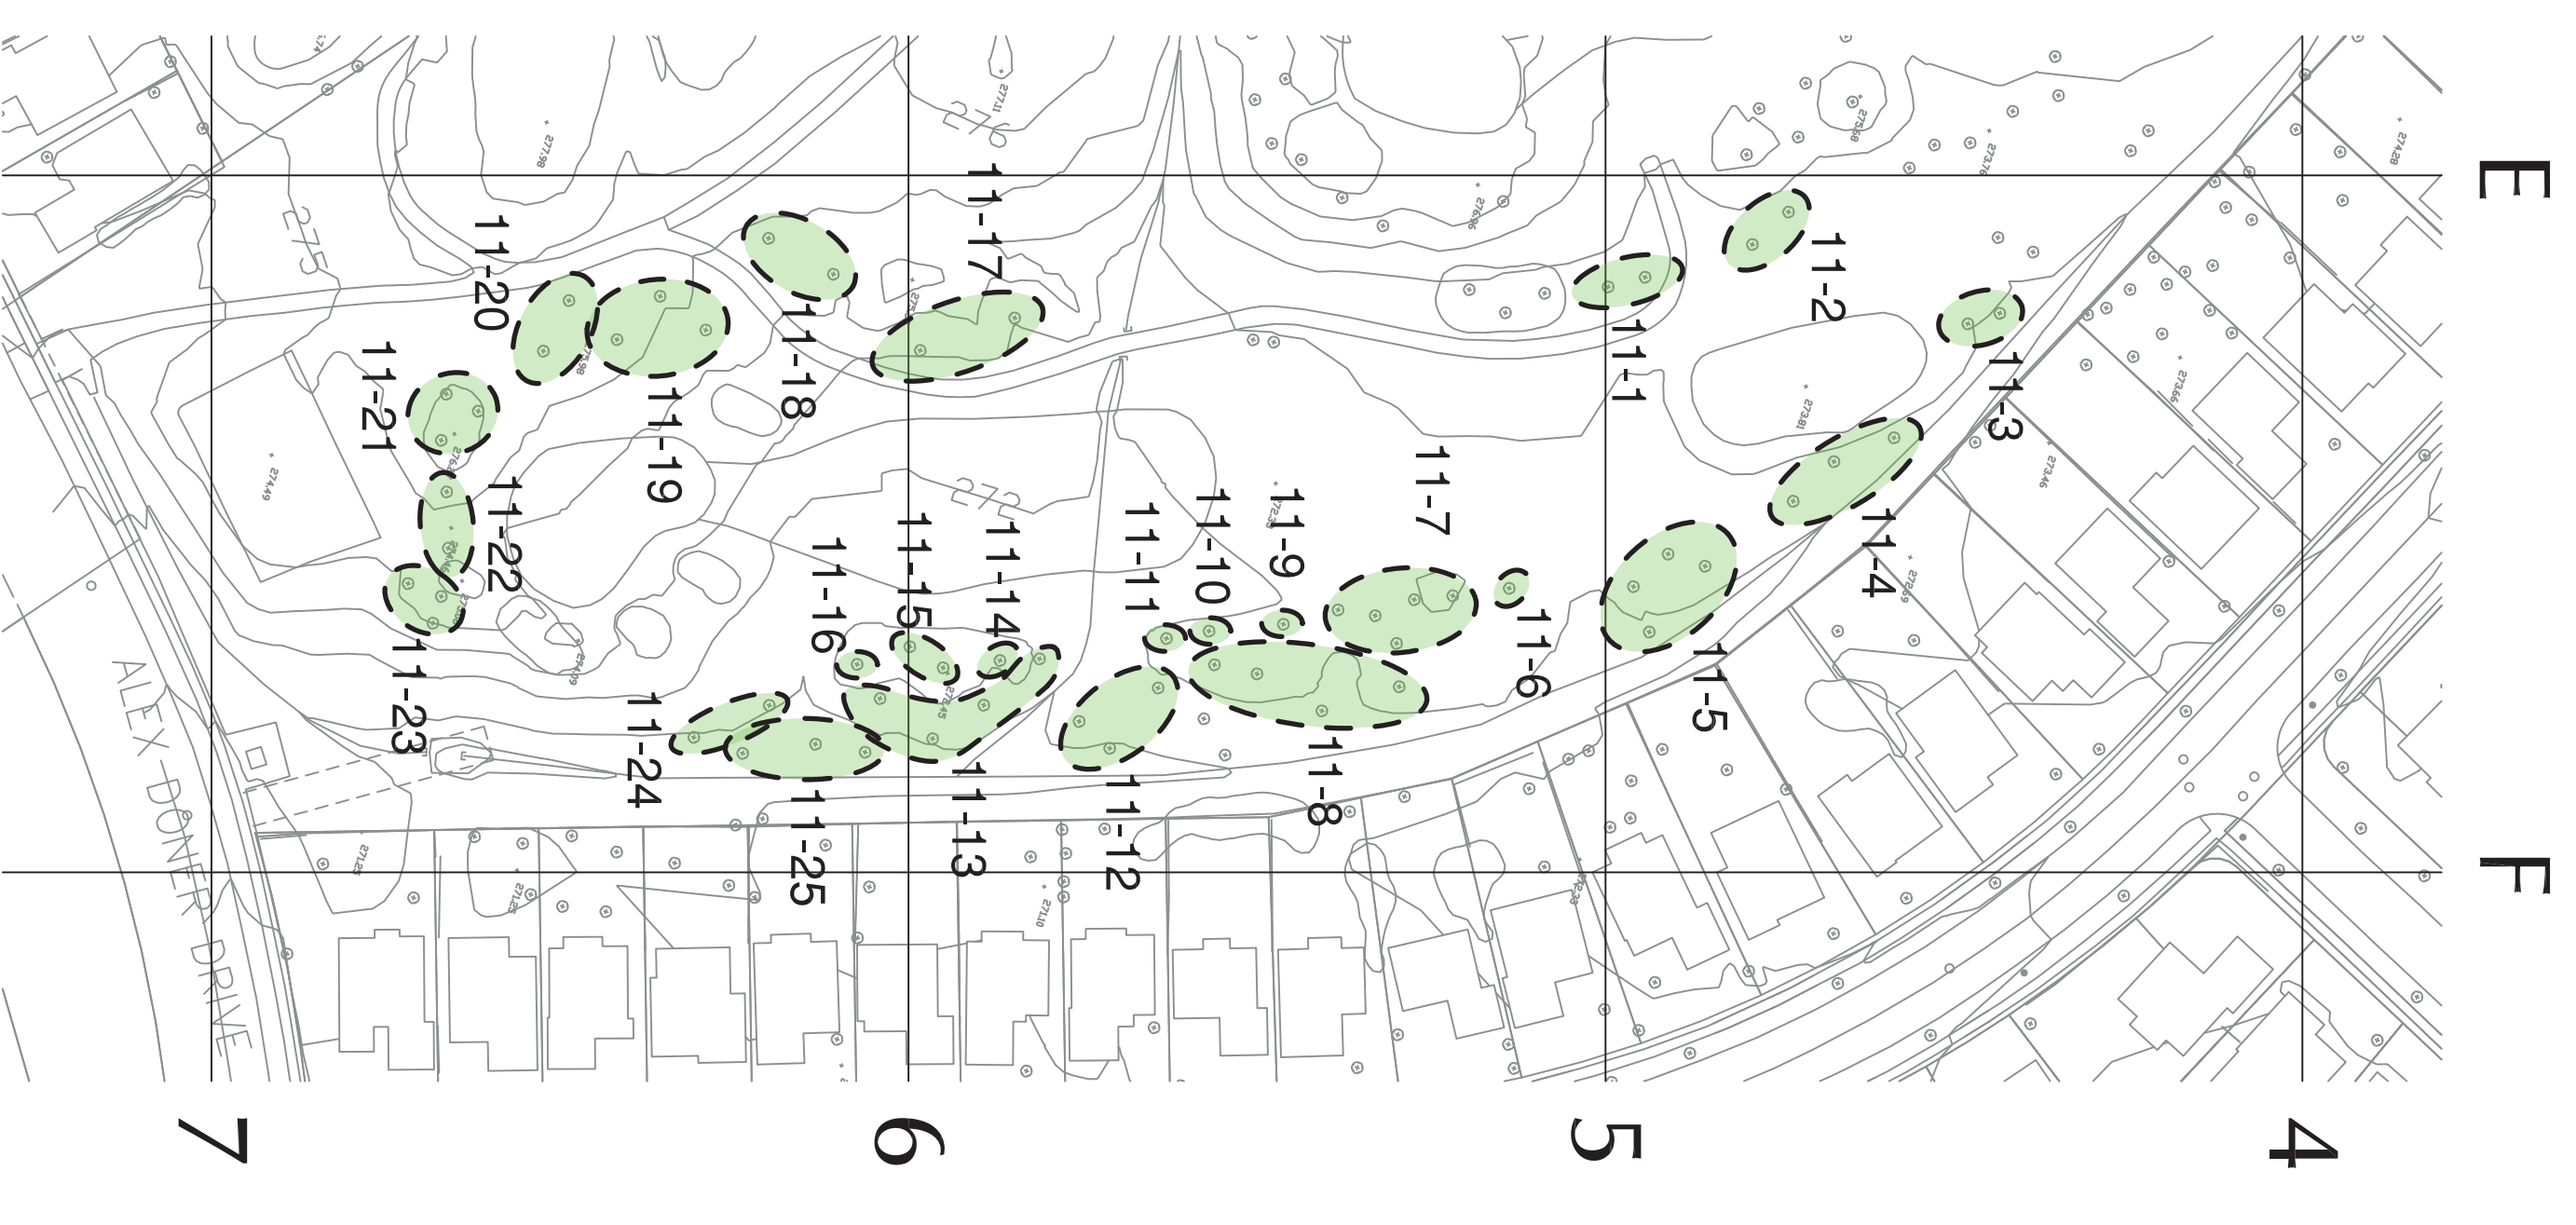
Hole 11 Plan Scale: 1:1000

Tree No.	Species Botanical Name	Common Name	Qty	Size DBH (cm)	Condition
1	pinus nigra	Austrian Pine	2	40	good
2	acer platanoides Crimson King	Crimson King Maple	2	8	good
3	acer platanoides Crimson King	Crimson King Maple	2	8-20	good
4	malus sp.	Apple	3	15-20	good
5	pinus nigra	Austrian Pine	4	20 - 30	one poor; three good
6	acer saccharinum	Silver Maple	1	30	good
7	fraxinus americana	White Ash	6	Aug-20	good; roots exposed
8	pinus nigra	Austrian Pine	4	25 -30	healthy but stunted with some dieback
9	acer saccharinum	Silver Maple	1	40	good; roots exposed
10	fraxinus americana	White Ash	1	15	good
11	pinus nigra	Austrian Pine	4	30 - 40	healthy but leaning
12	acer saccharinum	Silver Maple	1	22	good
13	fraxinus americana	White Ash	2	Dec-20	good
14	acer saccharinum	Silver Maple	1	28	good
15	pinus nigra	Austrian Pine	2	35	1 fair; 1 good
16	acer platanoides	Norway Maple	2	30	TS; roots expose; good
17	acer saccharinum	Silver Maple	3	20 - 28	good; two are succoring

18	pinus nigra	Austrian Pine	2	35 - 40	one good; one poor due to DTB
19	acer platanoides	Norway Maple	3	30 - 32	good; TS; Roots exposed
20	pinus nigra	Austrian Pine	2	32	good
21	acer platanoides	Norway Maple	3	30	good; TS
22	pinus nigra	Austrian Pine	2	30 - 35	one poor; one fair; DTB; dieback
23	acer saccharinum	Silver Maple	2	12 - 15	good; minor trunk damage; succoring on two
24	fraxinus americana	White Ash	3	15	good
25
